Residential Home Inspection Report

For the home at Some Town, Maine

Inspector Skip Dunning, CPI - NACHI # 18062901

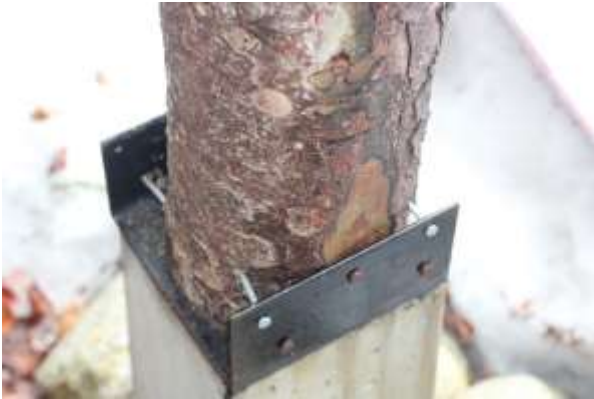
Figure 16 Improper materials

I observed many safety issues with the construction of the deck. The deck posts were logs, which while aesthetically pleasing, should not be relied on for shoring up a deck. The fastenings were not proper from the posts to the deck, there were screws holding some of the joist hangers, the ledger board was screwed rather than lagged and there was no spacing in the deck boards on the side deck which is open to the elements which can lead to pooling and eventually degrade the quality of the decking. There was no railing on the stairs leading to the entrance which should be addressed for safety issues.

In summary, Recommend further evaluation by a licensed contractor for safety concerns.

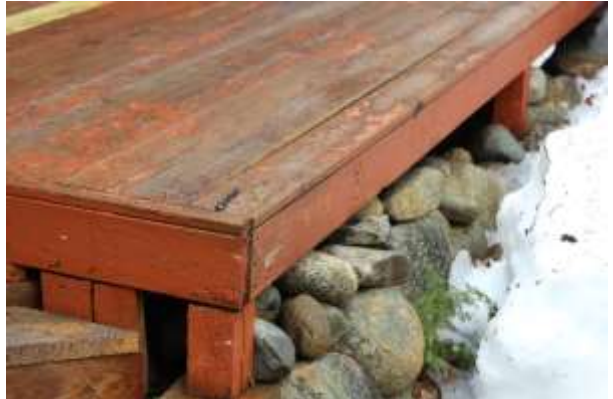
Figure 17 Lack of railing

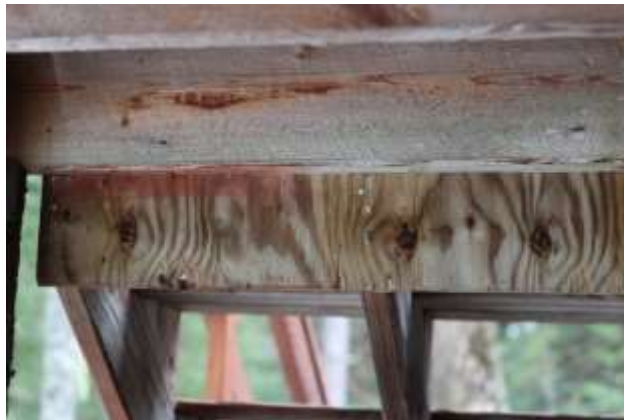
Figure 19 Improper attachment

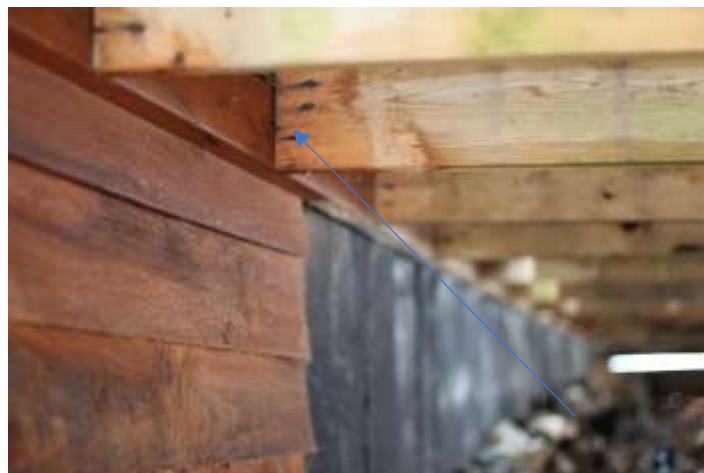
Figure 20 Lack of Joist Hangers

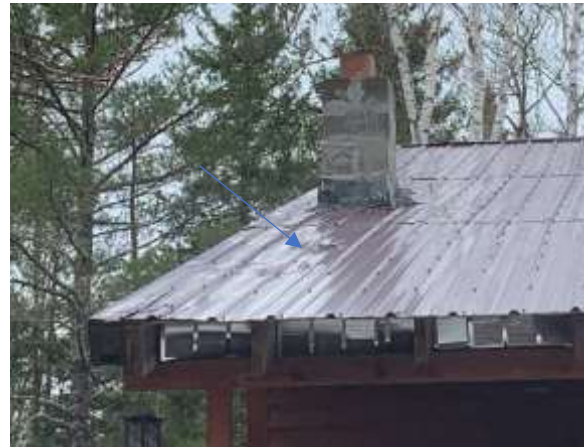
Figure 24 Damage to roof below chimney area

I observed an area just below the chimney that appears to be mechanical damage. The metal is dented in this area and could be a concern for the life expectancy of the material. **Recommend further evaluation by a roofing expert.**

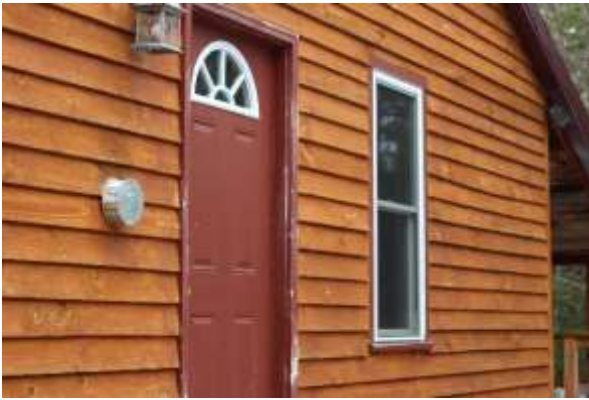
Figure 25 Missing Flashing at top of door

Several key areas of the home were missing the proper flashing. Flashing is necessary to help keep water from entering the home. There was missing flashing on the doors and all windows of the home. The entry door showed signs of water damage at the top of the casing due to no installed flashing. There was flashing also missing from the ledger board of the porch and deck areas.

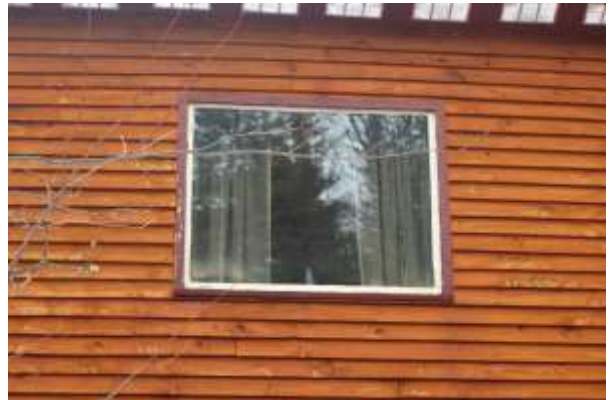
Figure 26 Missing Flashing at top of window

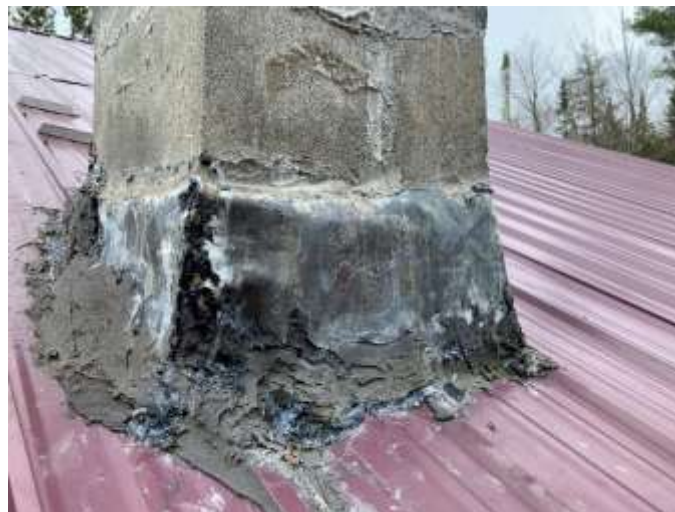
Observed a flued concrete block chimney that was being used for a wood burning stove in the home. The condition of the flashing was inadequate as evidenced by the excessive amount of mastic used to caulk around the chimney. There was evidence of past leaks inside the home around the chimney structure.

Figure 27 Improper flashing

Recommend further evaluation by a roofing expert to ensure there are no further leaks from this installation.

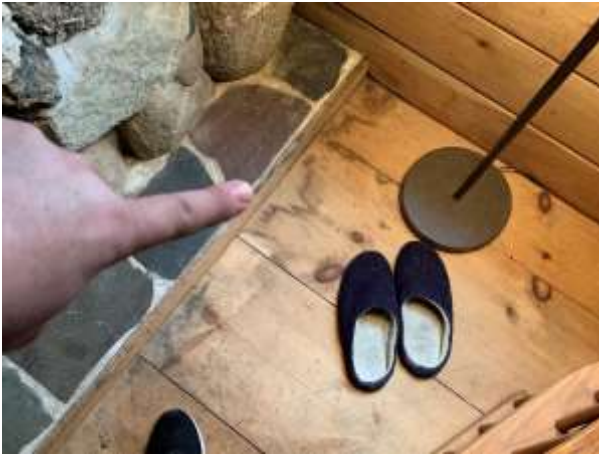
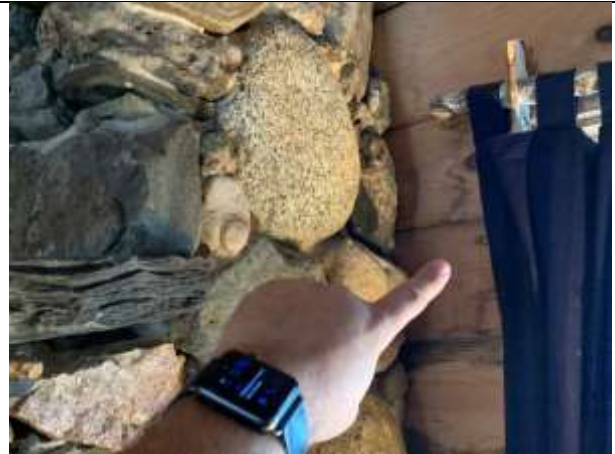
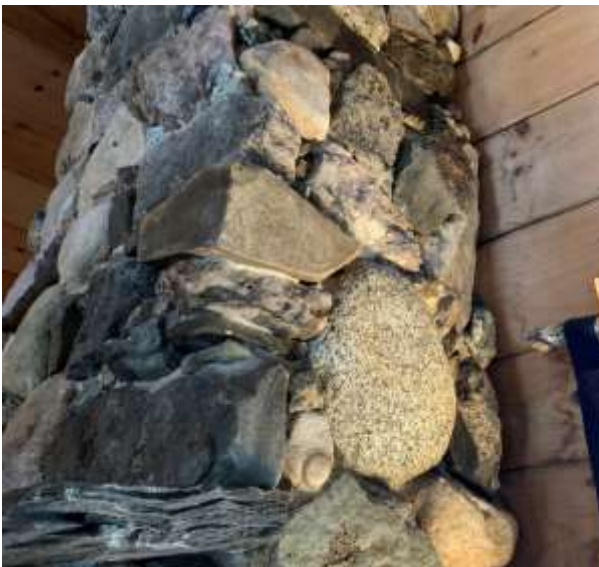
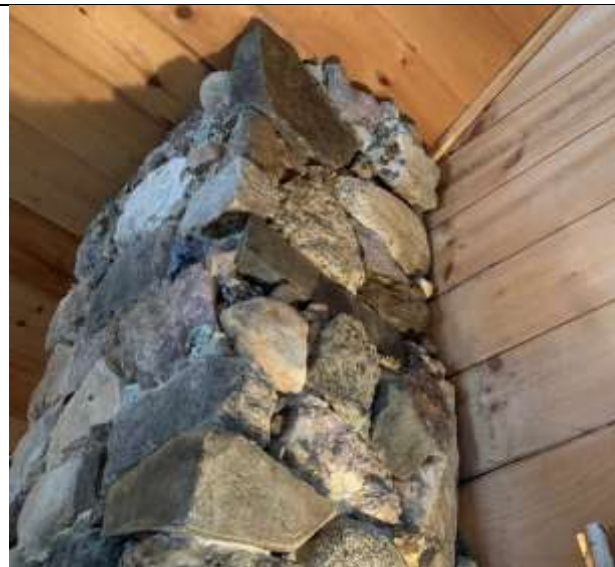
The floors, walls and ceilings were wood and showed no issues other than water staining present at the right side of the chimney structure. I took infrared photos of the area and tested with a moisture tester which indicated that there were no active leaks at the time of the inspection. That is not to say there will not be future leaks in this area however, and it is **recommended that you have a further evaluation by a roofing professional to address the chimney flashing area.**

Figure 32 Water Staining

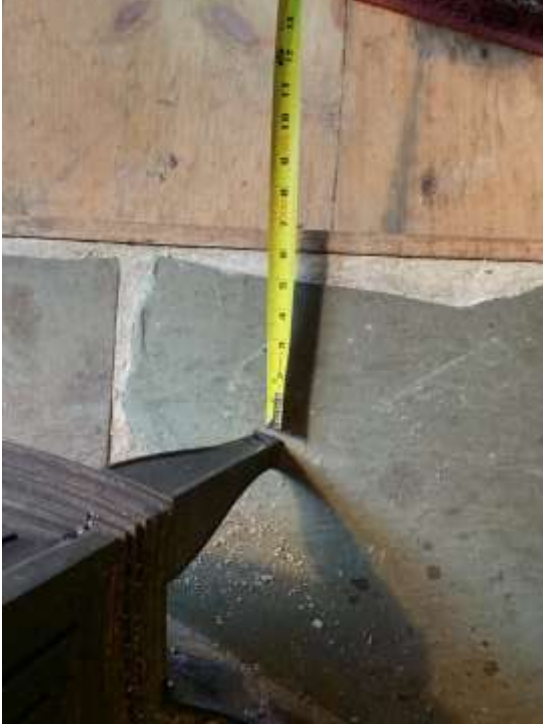
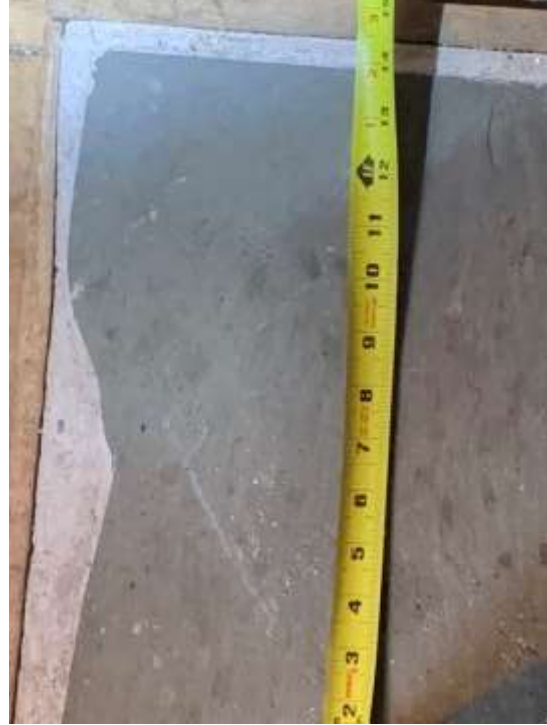
Figure 39 Improper Clearance

I observed that the hearth extension was less than 20 inches in front of and less than 8 inches beyond each side of the woodstove. These are the recommended safety requirements for woodstoves and may affect insurance rates for the home. **Recommend further evaluation by a professional woodstove installer.**

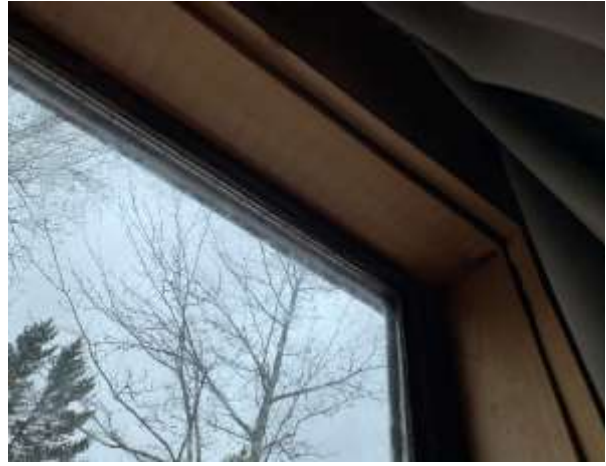
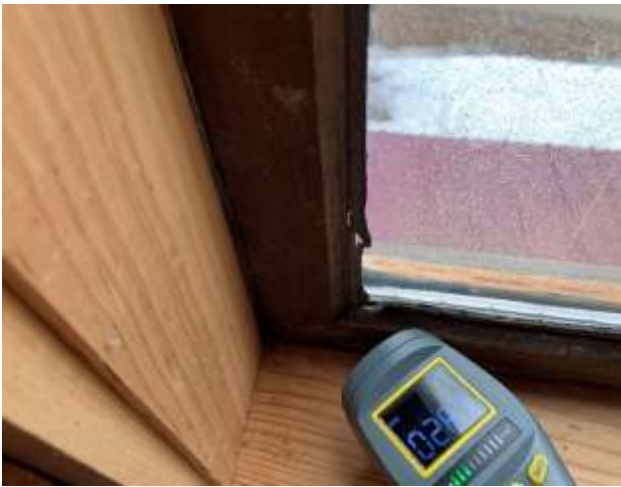
Figure 49 Picture Window Condition

The picture window showed some signs of moisture at the sill and some signs of deterioration. This could be the negative result of poor flashing or condensation. Maintenance will be required in this area. ***Recommend further evaluation by a licensed contractor or the homeowner may consider painting as a DIY project soon.***

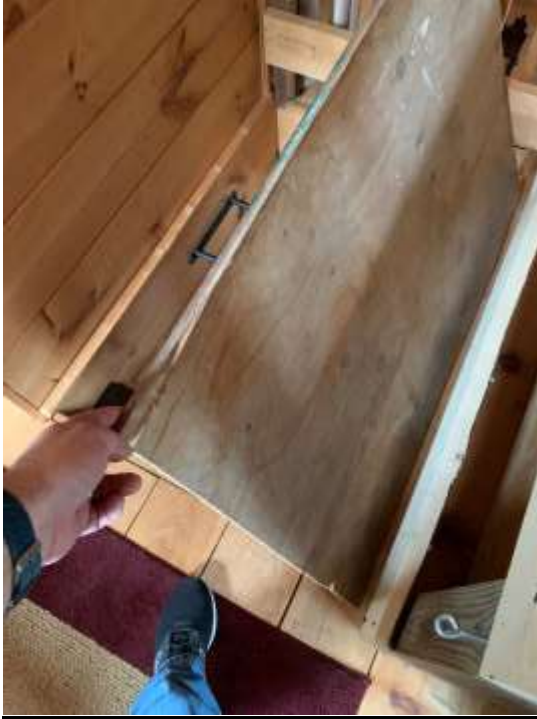
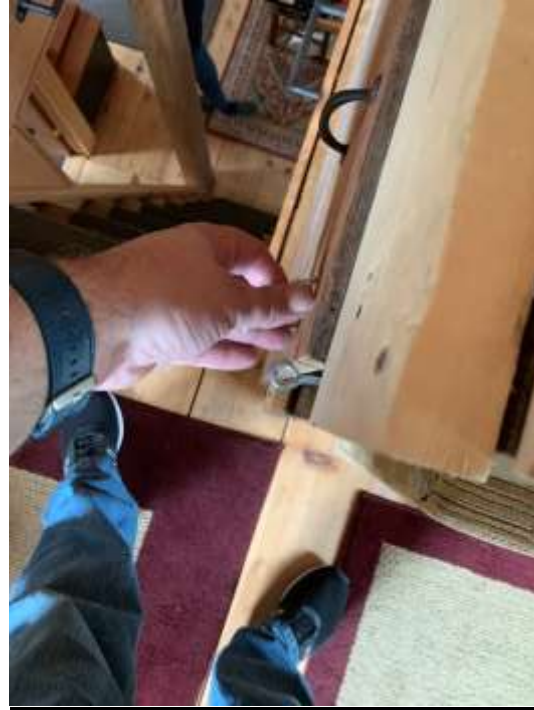
Figure 51 Trap Door

The entryway to the second bedroom had a plywood "trap door". There was a locking mechanism to keep the door secured when not in use and a handle on the entry side of the door. There was not a handle on the bedroom side which could pose a safety hazard if the room is occupied and the door is closed. ***Recommend adding a means of lifting the door or reconfiguring the access altogether for safety.***

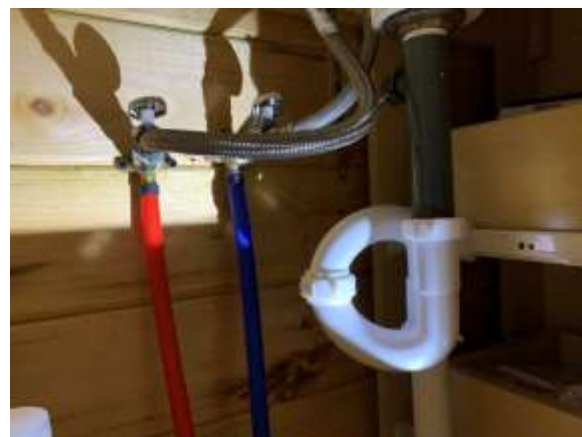
The water closet flushed as expected with no visible leaks and there was no play between the toilet and flooring connection. The ventilation source was a window that operated and locked as designed. The hot water from the faucet tested at 75.7°, which is a low temperature for hot water. The average temp should be 120°F to kill any bacteria but no more than 125°F to avoid scalding. The mechanical stop worked properly. I observed a noticeable drop in water pressure when two or more faucets were run at the same time. The trap under the sink was an "S" type trap which is not acceptable to modern standards. Traps provide a water barrier to keep sewer gasses from entering the home and help to eliminate drainage issues. These types of traps tend to siphon the water out of the trap leaving the drain open to sewer gasses or rodent infestation. **Recommend replacement to a proper "P" type trap by a licensed plumber.**

Figure 55 Improper "S" Trap

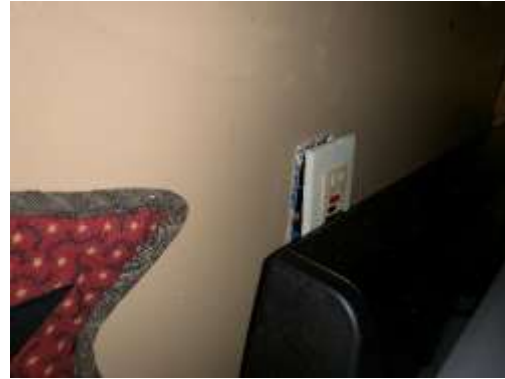
I tested the GFCI receptacle for proper operation. The receptacle behind the stove was loose. **Recommend further evaluation by a licensed electrician.**

Figure 61 Loose Receptacle

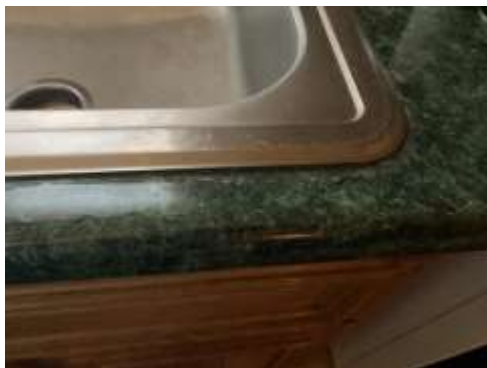
Figure 62 Loose Sink Connection

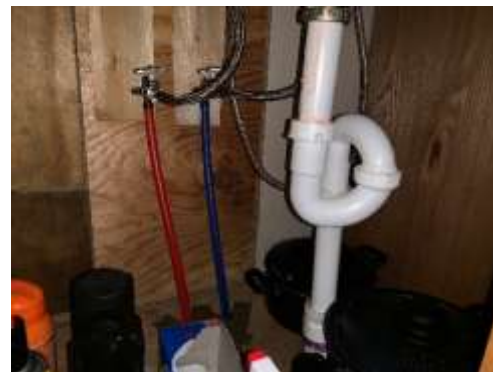
Figure 63 Improper "S" Trap

I observed proper drainage of the sink. I observed a noticeable drop in pressure when more than one faucet was operated simultaneously. The hot water temperature at the sink was 78.1° and the sprayer worked as designed. There was an improper "S" trap at the sink. The sink was not properly fastened to the countertop. **Recommend further evaluation by a licensed plumber regarding the trap configuration.**

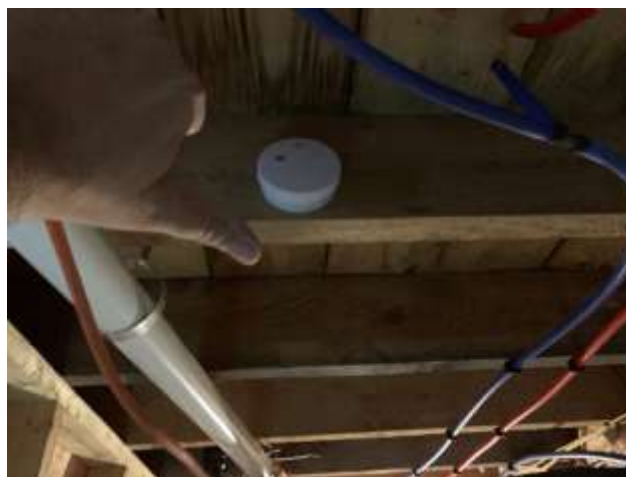
There was a smoke alarm that did not function at the time of the inspection. This alarm was installed in the non-habitable area of the basement. There should be one here, and another in the habitable area along with a Co alarm due to the woodstove installation in that room. **Recommend replacement and the addition of another for safety.**

Figure 73 Inoperable Smoke Alarm

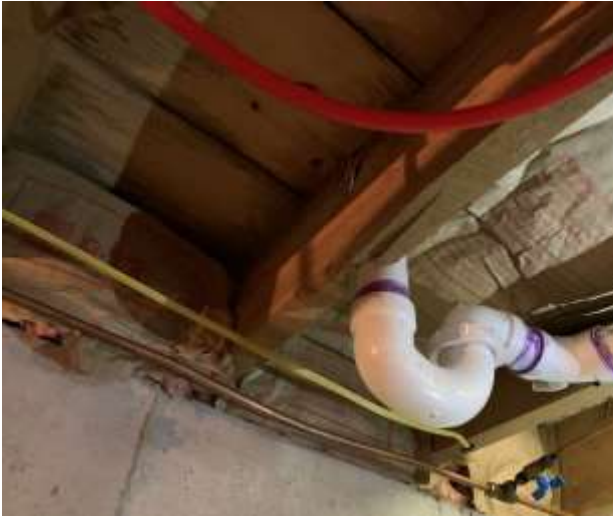
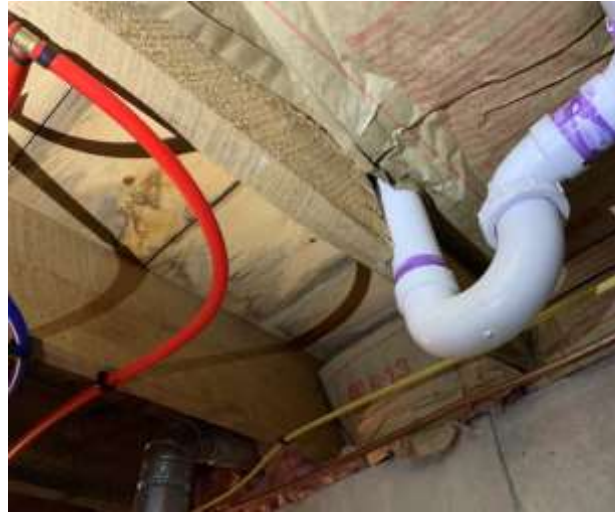
The floor was observed as being poured concrete which was painted. I did not observe any visible signs of cracking. I observed areas where the floor joists were cut/notched to accommodate plumbing which is a concern.

Figure 74 Cut Joist

Figure 75 Cut/Broken Joist

Recommend further evaluation by a professional contractor for remediation.

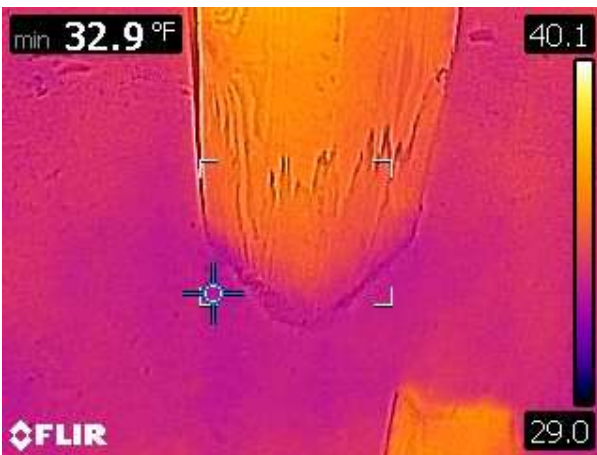
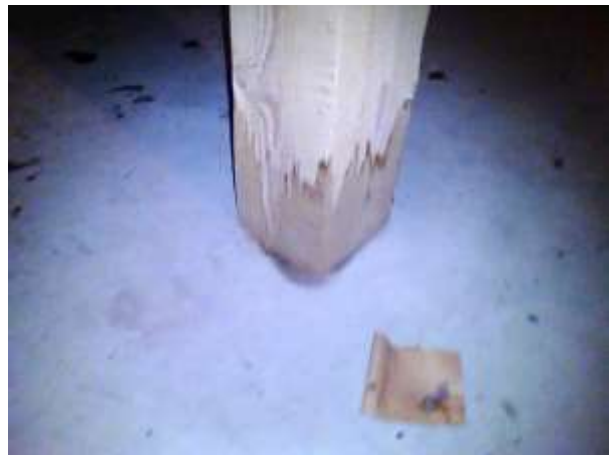
Figure 78 Moisture wicking

There were visible signs of moisture wicking. I could not ascertain how recent nor if it will continue. There were indications of active water intrusion below the window on the wood side (back) of the home. This area is below the rear deck and had pooling water at the building. **Recommend further evaluation by a professional contractor.**

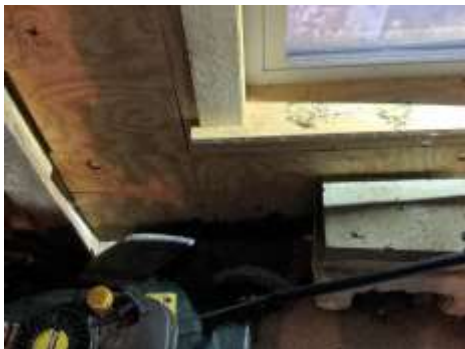
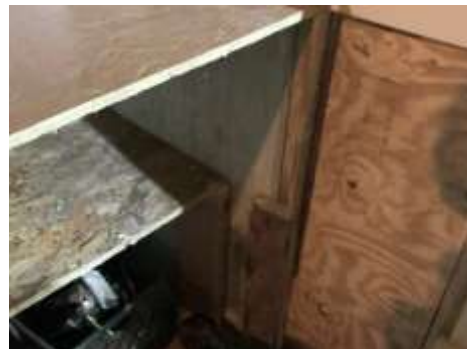
Figure 80 Active Water Intrusion

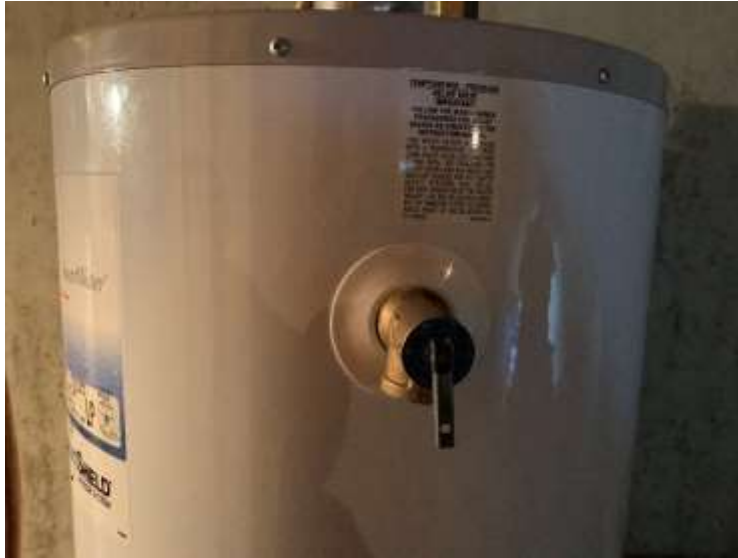
The water heater was a GE 30-gallon propane tank. I observed no indications of leakage. I observed an improper TPR valve connection. The TPR valve should have a discharge pipe attached that terminates within six inches from the floor. There was no discharge pipe installed on this unit at the time of inspection. **Recommend further evaluation by a licensed plumber.** The age of the water heater was 13 years. **The typical life expectancy of a water heater is 6 to 12 years. Recommend budgeting for a new water heater at some time.** For more information on this unit, visit <https://products.geappliances.com/appliance/gea-specs/GP30T06AVG00>

Figure 91 TPR Valve w/o termination

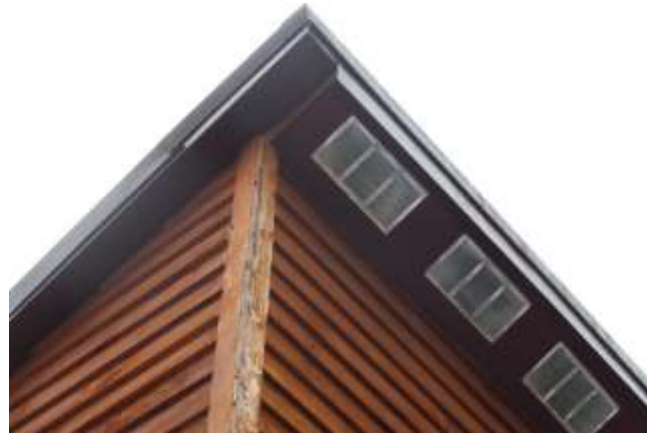
Figure 94 Plumbing Vent Termination

The vent system was plumbed so that the main vent was routed through the wall system and terminated to the soffit vents at the high side of the shed roof. It appeared that all fixtures were connected to the venting system. A plumbing vent should extend outside of the home to avoid any gasses entering the home through a window or other opening. This current configuration is not typical, and I would **recommend further evaluation by a licensed plumber.**

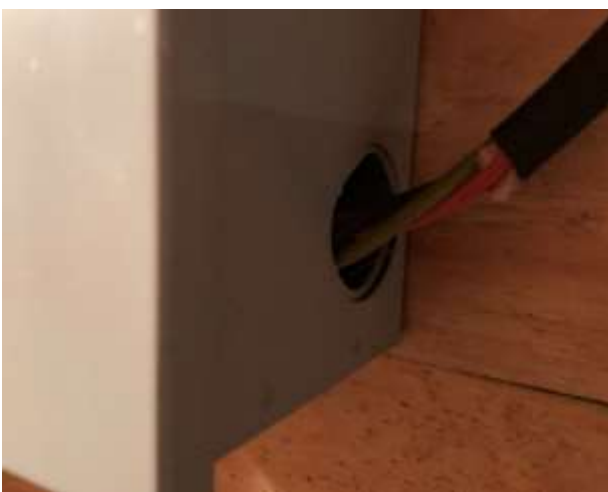
Figure 97 Improper fitting

The generator was wired directly to a shut off switch and then to the main panel. The entrance cable from the generator was routed through a knockout in the side of the switch panel. There was no means of fastening the wire and left a gap which could allow rodents to enter the panel. There was a missing knockout in the main panel which is a safety hazard. The main entrance to the panel from the generator shutoff was installed in a haphazard way and was not a proper installation. The cover to the panel was installed upside down which makes it difficult to read the circuit breaker labeling. The breakers and wiring looked proper, but I would **recommend further evaluation by a licensed electrician to address the above issues.**

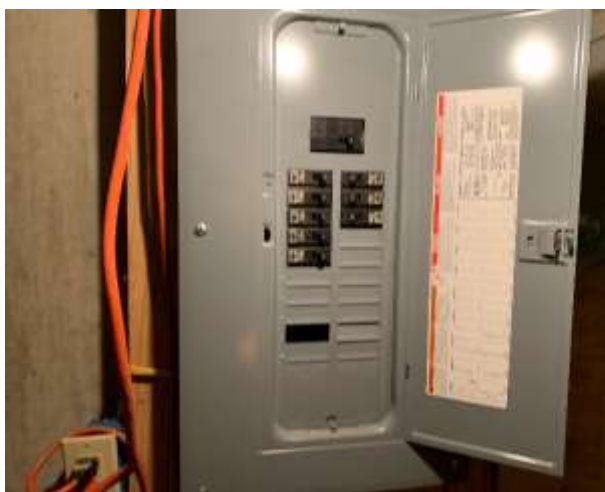
Figure 98 Missing Knockout

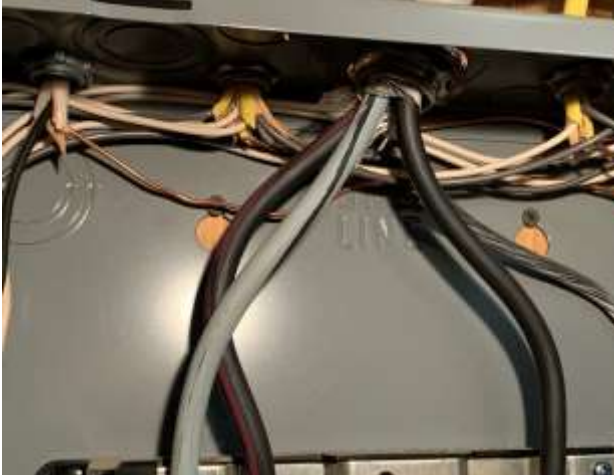
Figure 99 Improper connection

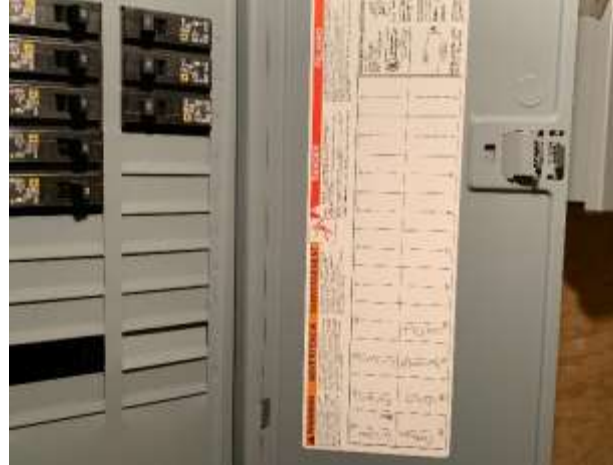
Figure 100 Labeling (wrong installation of cover)
