# Patriot Home Inspections, LLC Comprehensive Home Inspection Report

**Inspection Address: 1122 Harmony Avenue, Sometown, Maine**

**Date of Inspection: 7/8/2021**

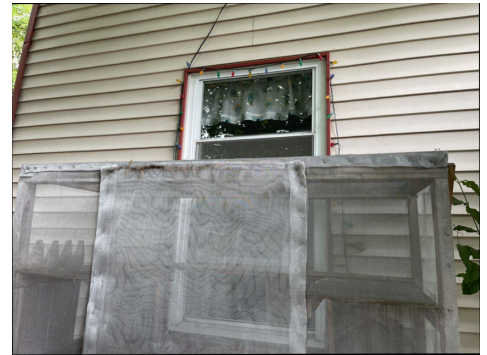
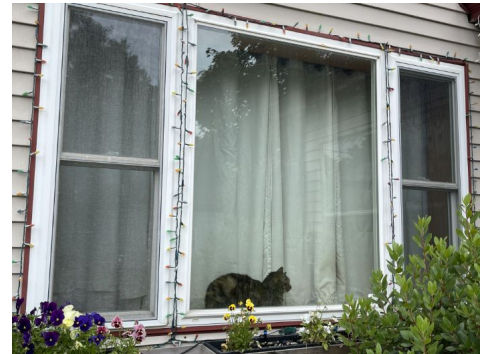
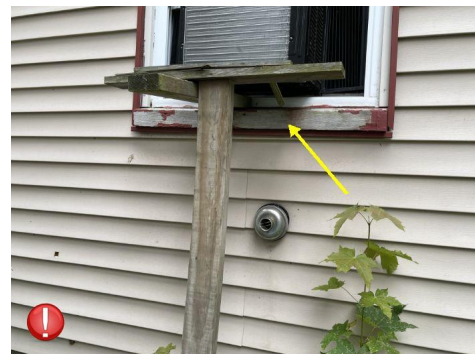
- Some window screens were missing and some were damaged.
- Peeling paint observed, suggest scraping and painting as necessary.
- Minor wood softening noted. Recommend ongoing maintenance.

Several ripped screens

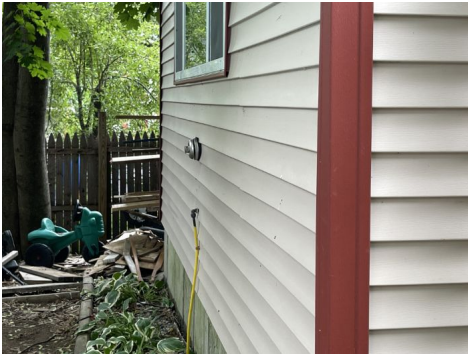
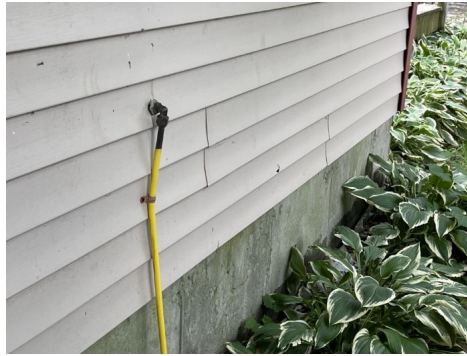
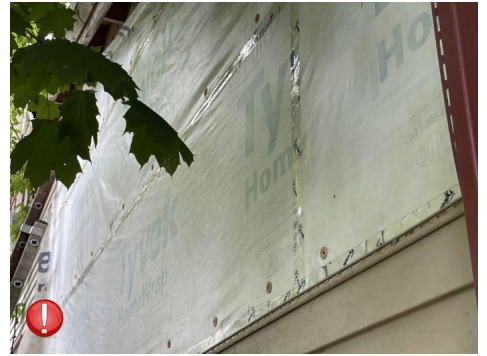
- Minor vinyl siding damage was observed. Typical but should be addressed to avoid moisture intrusion.
- There was an area of unfinished siding at the far side of the addition. Recommend having this sided as soon as possible.
- The dryer vent was uncovered at the time of the inspection. This allows vermin to enter the home via the dryer ductwork. Recommend repairs.
- The siding at the window flower boxes was pulled away from the home due to the weight and method of attachment. Recommend repairs to this area of siding to keep water from getting in behind the siding.

Unfinished siding

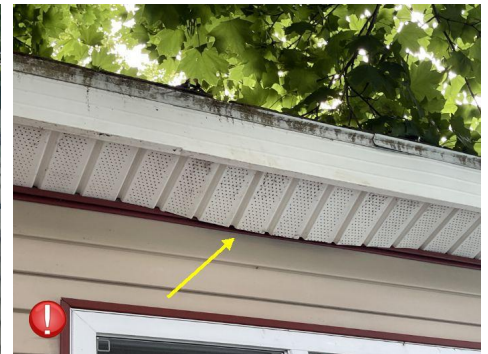
- There were areas of the eaves that had loose soffit coverings. Recommend repairs.

Loose materials at soffit

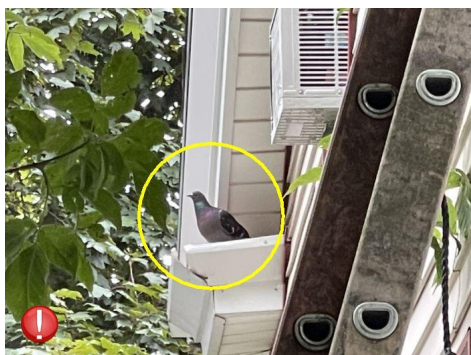
- There were open soffits noted. It was brought to my attention from a neighbor that there had been issues with squirrels at this home. Recommend further evaluation to determine a course of action to keep this from happening. I noted a pidgin roosting at the eaves, it was unknown if there may have been a nest there, but it came back several times.

Possible nesting

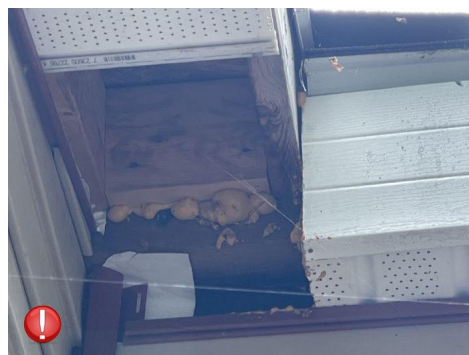
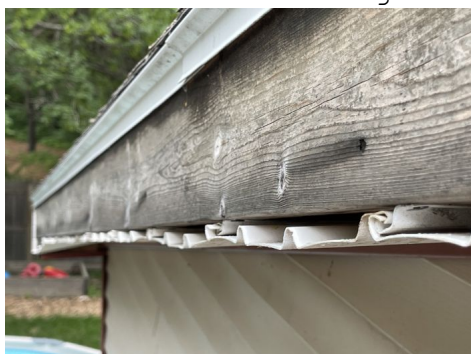
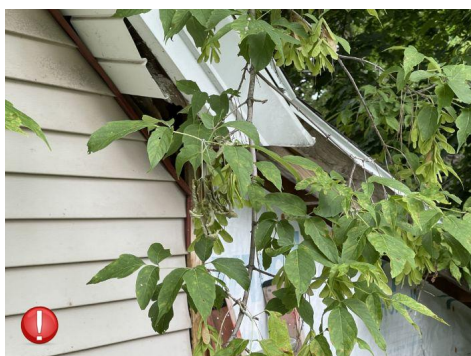
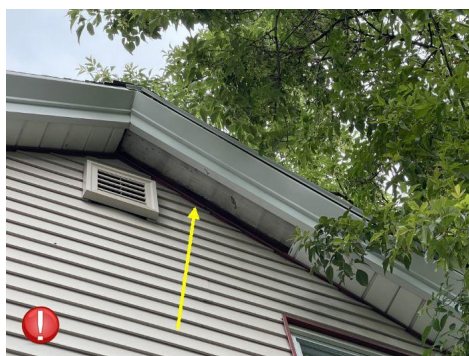
- A section of the fascia at the addition was missing. Recommend repairs.

Open soffits

Soffits missing

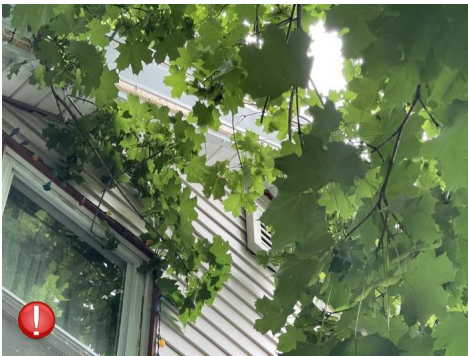
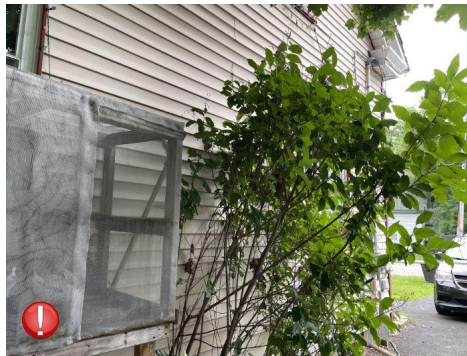
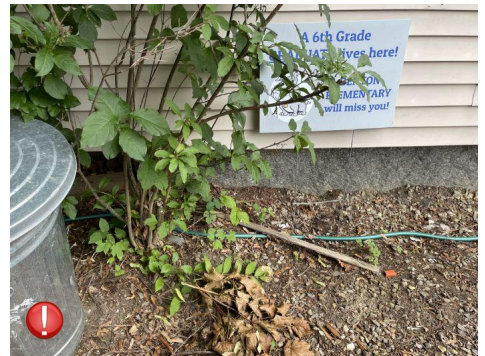
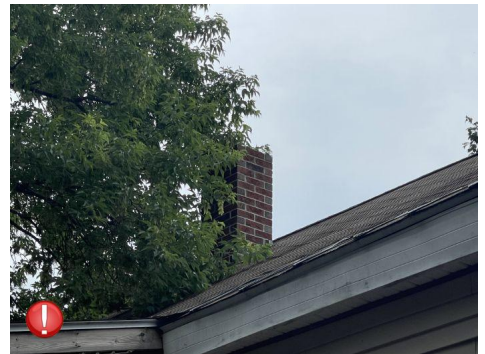
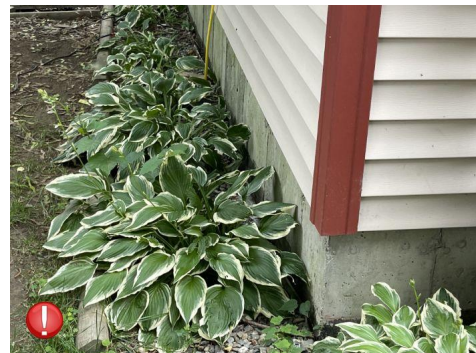
- Prune or remove any plants that are in contact or proximity to home to eliminate pathways of wood destroying insects.
- Trees were within 6 feet of foundation. Monitor for potential root damage.
- Trim trees that are in contact or proximity to home, as branches can abrade roofing or siding.
- Vegetation was too close to the home in areas. This can be detrimental to the siding of the home as well as introduce moisture into the foundation.

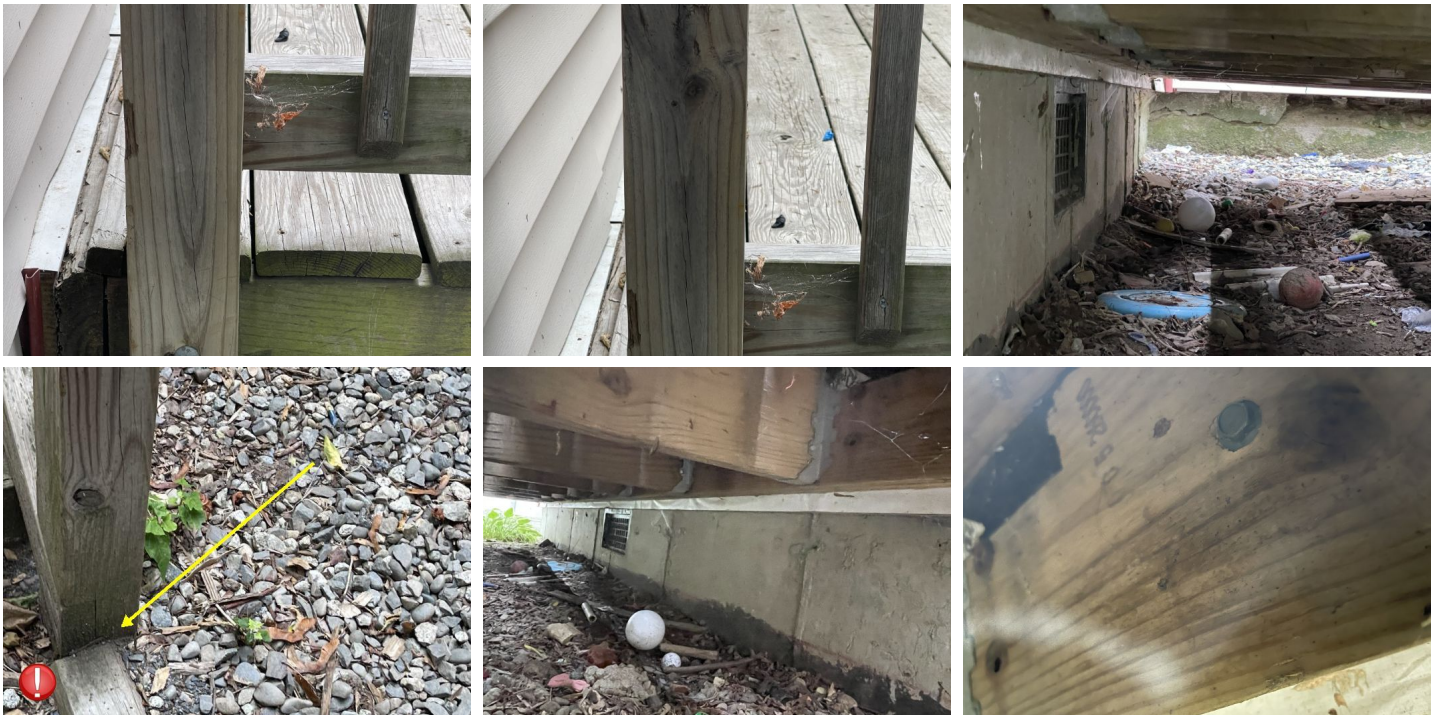
- **Wood to Soil Contact at deck supports. Deterioration may occur and insects may gain access to wood.**

Wood touching soil

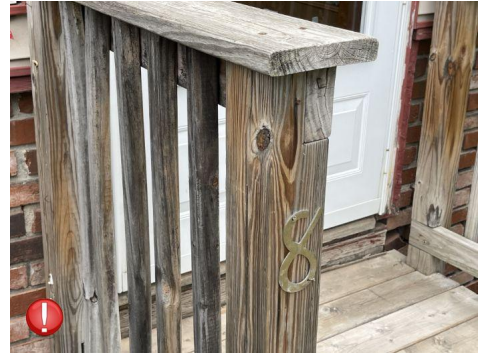
- Wood to Soil Contact at deck supports. Deterioration may occur and insects may gain access to wood.
- Unstable railings were observed.

Loose Railing

Unstable railing

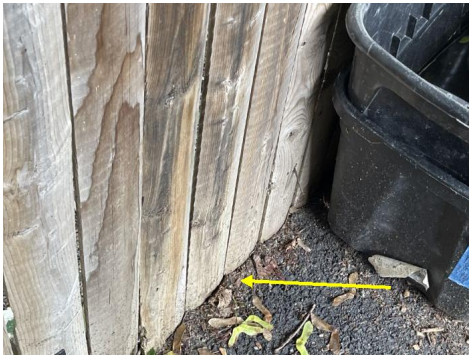
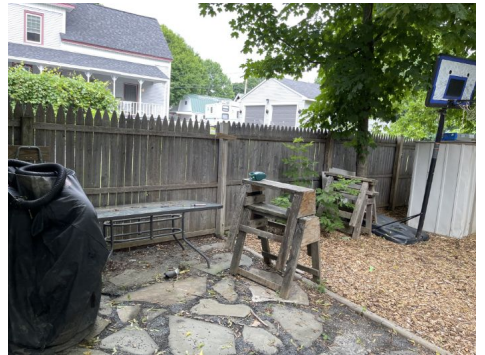
- Fence leaning in areas.
- Wood deterioration observed. Suggest repairs/replacement as needed.

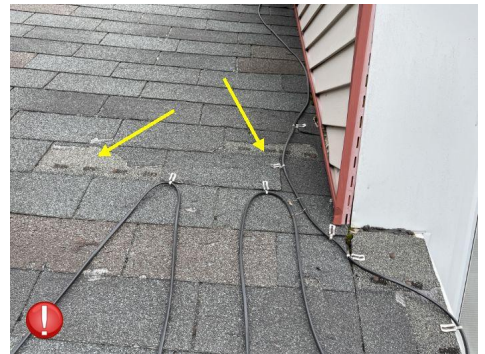
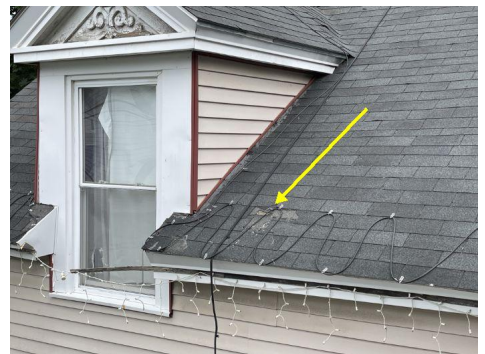
- Some shingles were observed to be damaged. Curling, missing shingles and/or tabs. Recommend repair by a roofing specialist.

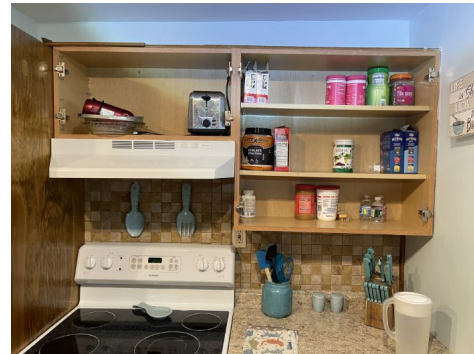
- Cabinets were missing doors at the time of the inspection. It is recommended to ask the homeowner if they are stored on the premises and request that they be installed prior to close.

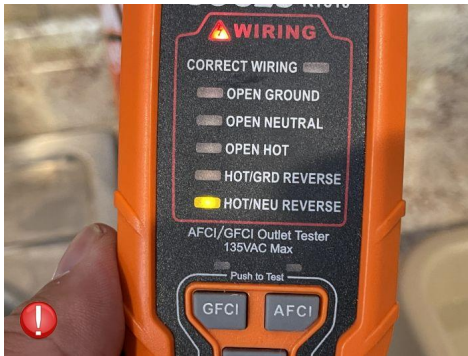
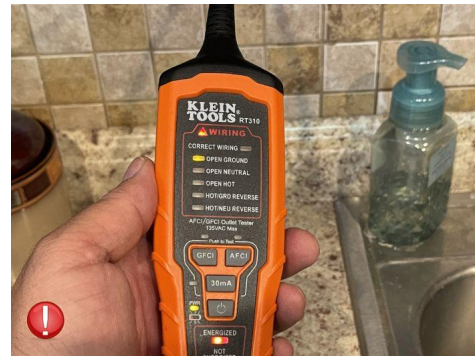
- There were open ground receptacles present at the time of the inspection.
- Reversed polarity on an electrical outlet is dangerous. If you accidentally reverse these wires the device you plug in to the receptacle may "work" but it is unsafe and risks a short circuit, shock, or fire.

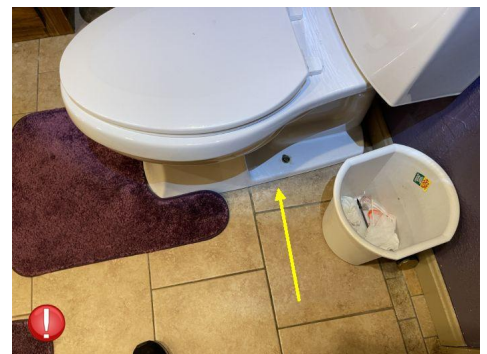
Caulking missing

No caulking

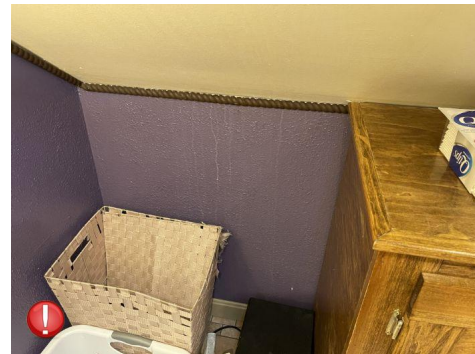
- There were some signs of elevated moisture in the bathroom, most likely caused from showering without the vent fan running or not running the fan long enough. This can cause issues with wallpaper and paint on the ceiling. It is highly recommended to run an exhaust fan with every shower and continue to run it for up to 15 minutes after your shower to remove as much moisture as you can.

Moisture streaking from lack of proper ventilation

Moisture streaking

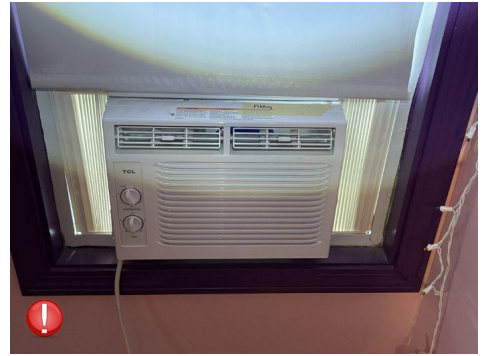
Most windows were fitted with AC units and were unable to be thoroughly inspected.

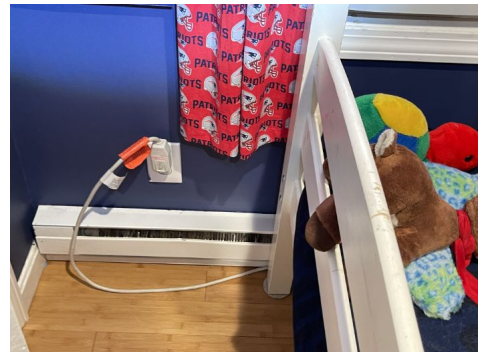
- Some outlets not accessible due to furniture and or stored personal items.
- Missing cover plates observed, suggest installing for safety.

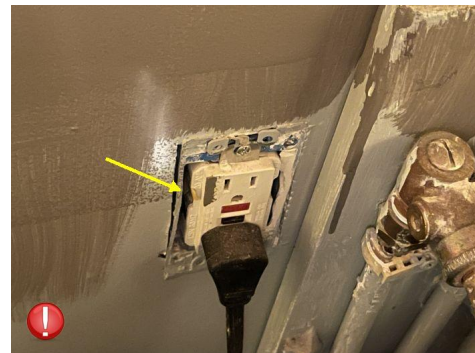
- Some outlets not accessible due to furniture and or stored personal items.
- Outlet cover plates missing.

Cover Missing

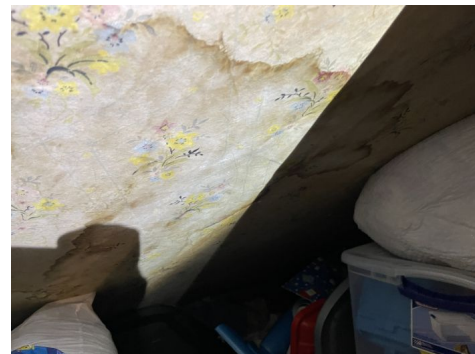
- Small stains noted on the ceiling. They tested dry at the time of the inspection.

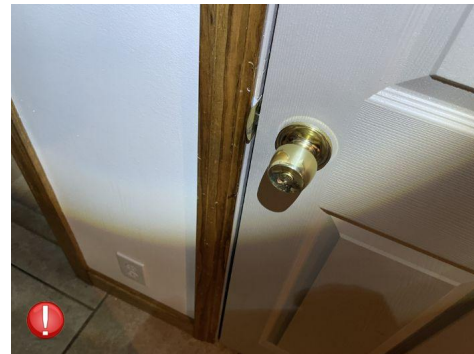
Basement door did not latch

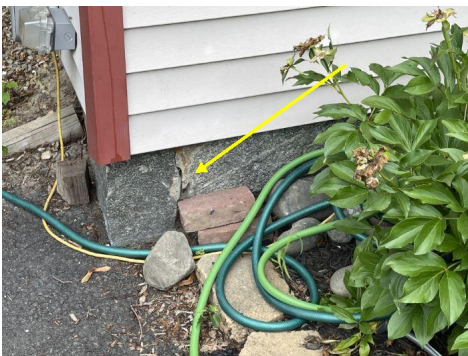
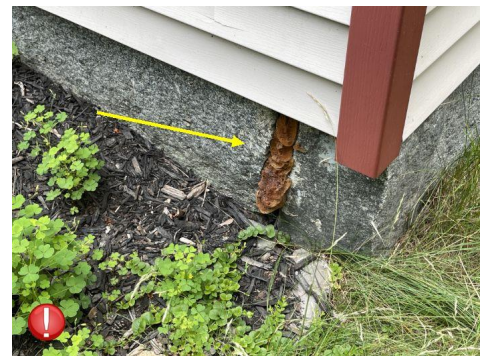
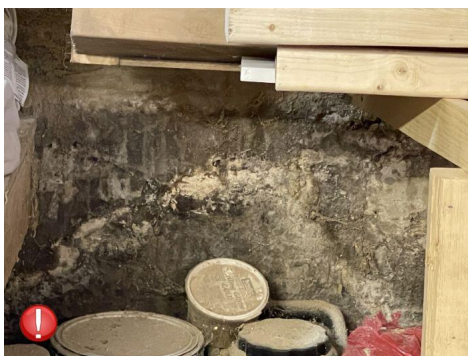
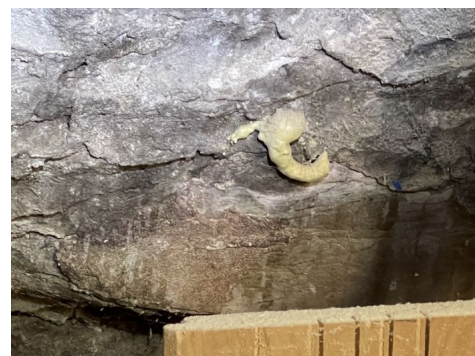
- Efflorescence is a crystalline deposit of salts that can form when water is present in or on brick, concrete, stone, stucco or other building surfaces. It has a white or greyish tint and consists of salt deposits left behind when water evaporates. In addition, efflorescence can appear as a powdery substance on floors and walls and requires special care to treat.
- Moisture intrusion was observed in numerous areas of the foundation. Moisture can create high humidity, mold & can damage stored items & finishing materials. Recommend a wet basement specialist review the foundation for correcting the water intrusion and advise as needed.
- Efflorescence observed; this is a mineral deposit left behind from previous exterior water infiltration.
- Limited review due to storage of personal property and finished walls.

Efflorescence noted

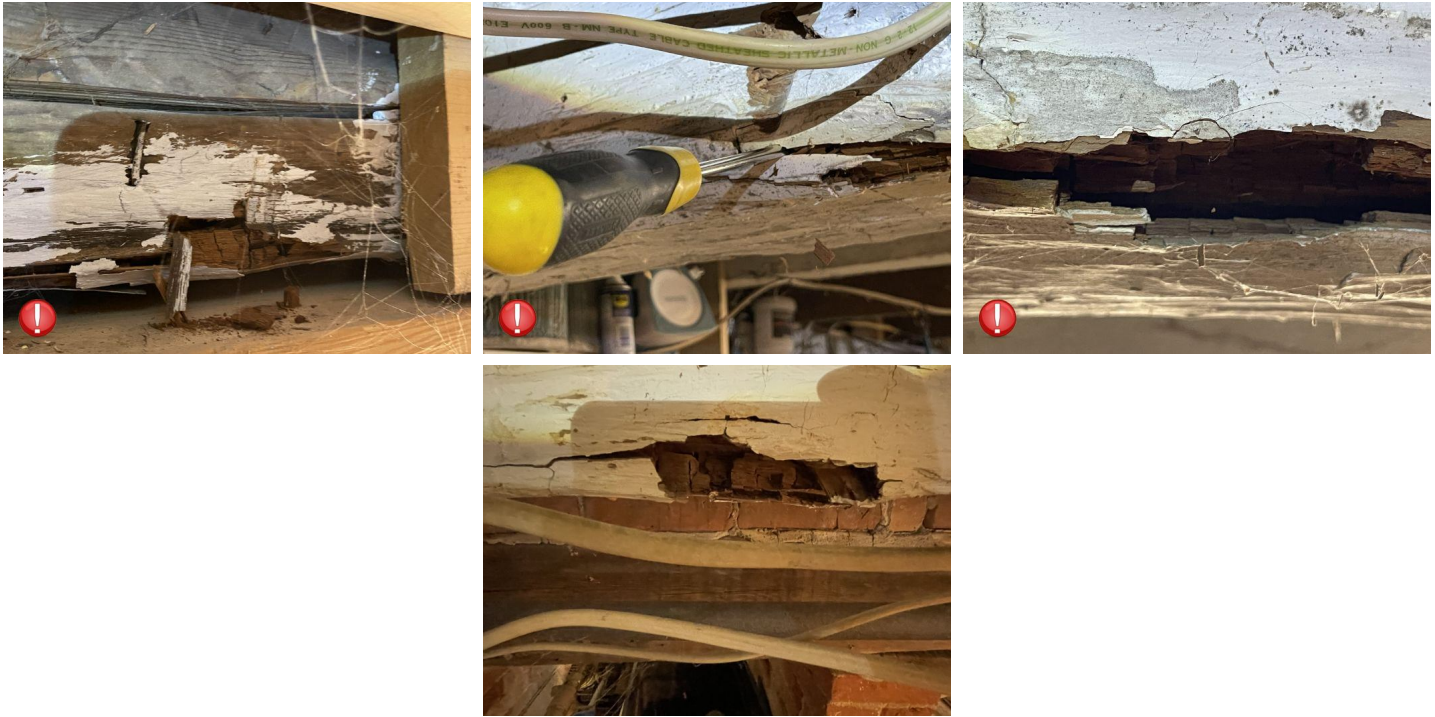
- Some areas are not visible for inspection due to wall/ceilings covered which prevents review of structural members.
- Deterioration/ damage of one or more floor joist noted. Recommend review and repair by a Qualified Contractor to evaluate load bearing members.

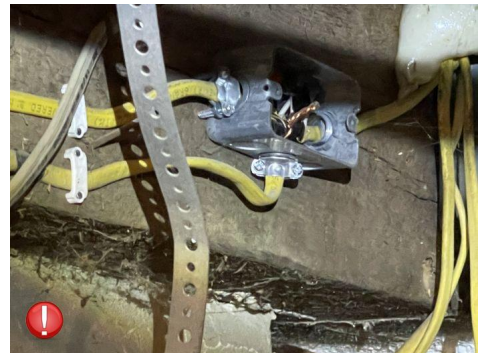
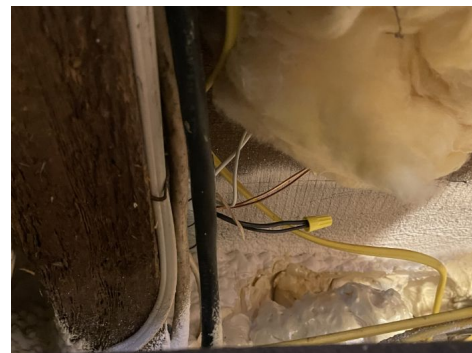
- Open electrical boxes. All electrical boxes should be covered for safety.
- Since ungrounded receptacles were noted in the home, buyer is cautioned that proper grounding is strongly urged where sensitive electronic equipment is used. Ungrounded receptacles do not offer protection for computers etc. Consultation with a qualified electrical contractor is recommended.

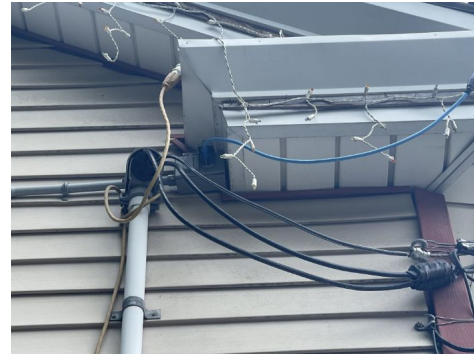
- There was an inadequate drip loop at the service entrance. Recommend repair by the electric company.

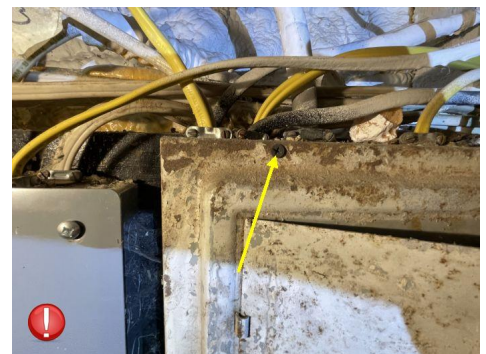
Missing screws

Extreme safety issue
