Residential Home Inspection Report

For the home at Some Town, Maine

Inspector Skip Dunning, CPI - NACHI # 18062901

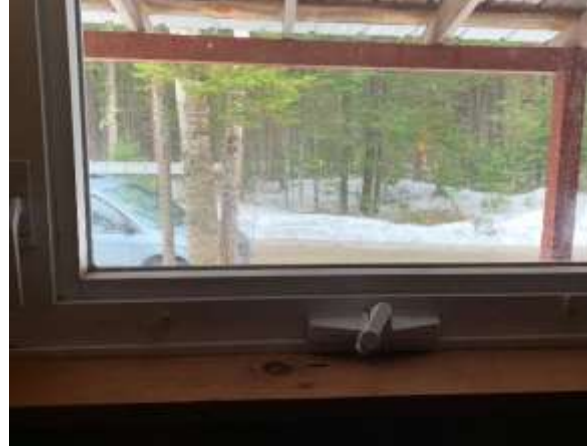
Figure 8 Casement Window in Living area

Window fogging is normally the result of bad or broken seals. Leaks as small as a tip of a needle can result in foggy windows. This could be the result of poor installation, low quality windows, or even manufacturing error. All windows of this type will fail over time. **The average life expectancy for vinyl windows is 20 to 40 years.** Regular cleaning of both the glass and the vinyl frame is recommended to keep them in good shape. The windows in the living area were casement and one was missing a crank. Most hardware stores should carry them.

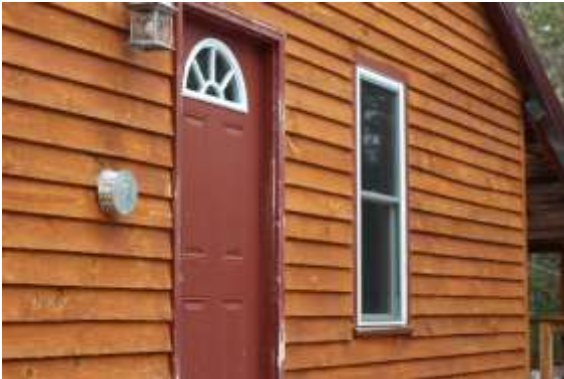
Figure 9 Main Entrance Door

The front and rear deck door both had deadbolts but did not line up properly. **Recommend realigning deadbolts for proper operation.** The weather stripping was in good shape and I observed no visible gaps. Below is a thermal image showing normal temperature differences at the trim around the doorway.

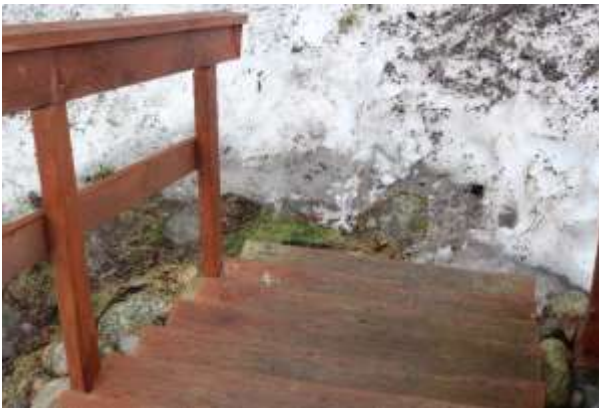
Figure 18 No Graspable Handrail

I observed many safety issues with the construction of the deck. The deck posts were logs, which while aesthetically pleasing, should not be relied on for shoring up a deck. The fastenings were not proper from the posts to the deck, there were screws holding some of the joist hangers, the ledger board was screwed rather than lagged and there was no spacing in the deck boards on the side deck which is open to the elements which can lead to pooling and eventually degrade the quality of the decking. There was no railing on the stairs leading to the entrance which should be addressed for safety issues.

In summary, Recommend further evaluation by a licensed contractor for safety concerns.

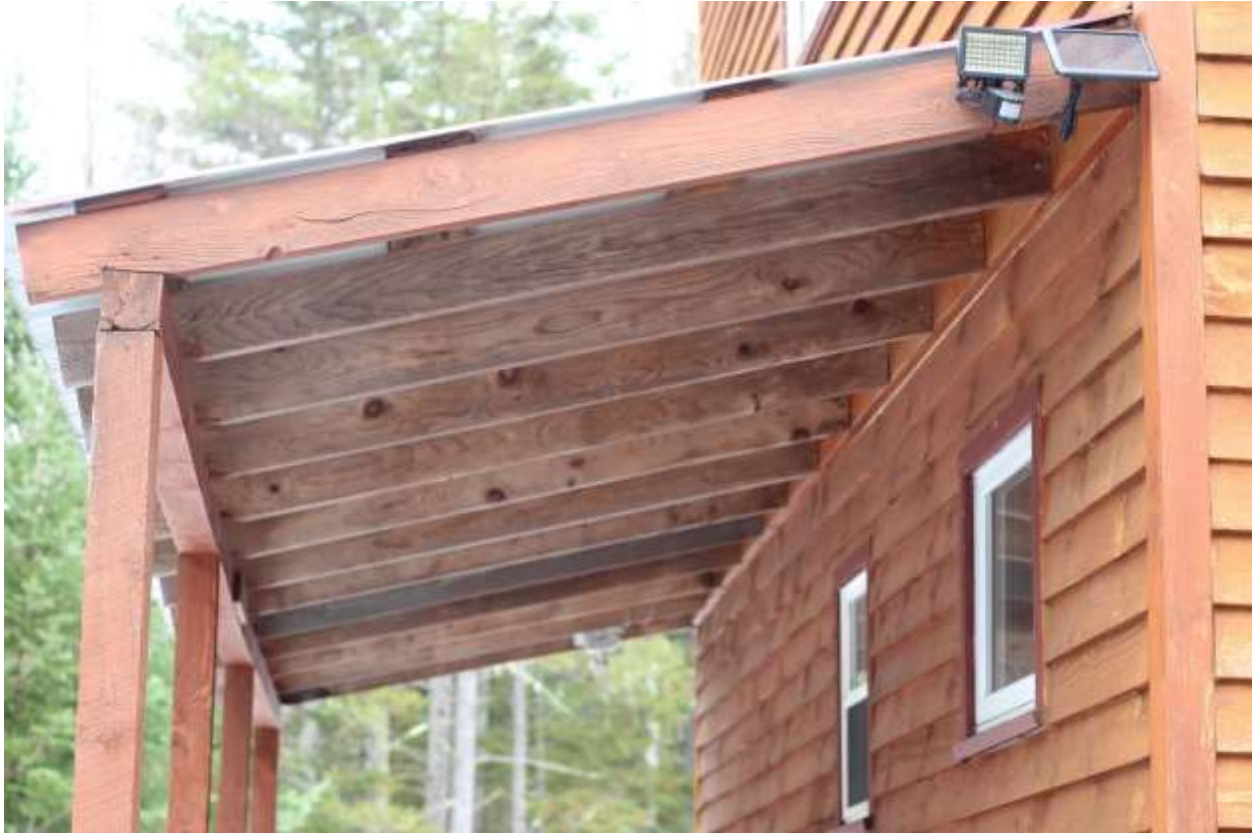
The front porch roof was held by nails into the ledger. Joist hangers should be used here due to the possibility of snow load on the roof. There were no railings on this structure which could be a safety issue with small children.

Figure 21 Front Covered Porch

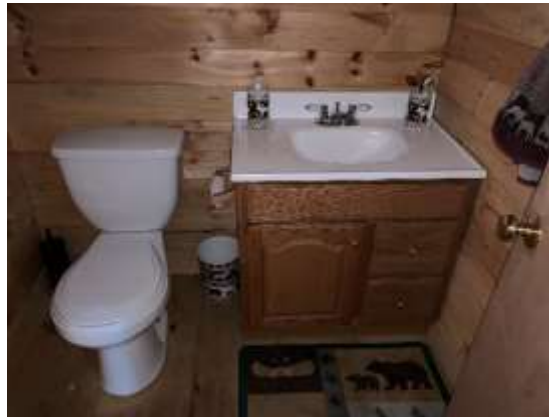
Figure 53 Main bathroom

The water closet flushed as expected with no visible leaks and there was no play between the toilet and flooring connection. The ventilation source was a window that operated and locked as designed. The hot water from the faucet tested at 75.7°, which is a low temperature for hot water. The average temp should be 120°F to kill any bacteria but no more than 125°F to avoid scalding. The mechanical stop worked properly. I observed a noticeable drop in water pressure when two or more faucets were run at the same time. The trap under the sink was an "S" type trap which is not acceptable to modern standards. Traps provide a water barrier to keep sewer gasses from entering the home and help to eliminate drainage issues. These types of traps tend to siphon the water out of the trap leaving the drain open to sewer gasses or rodent infestation. **Recommend replacement to a proper "P" type trap by a licensed plumber.**

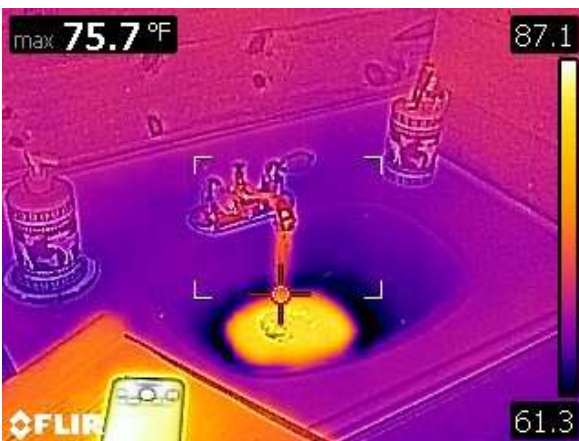
Figure 54 Sink Temperature

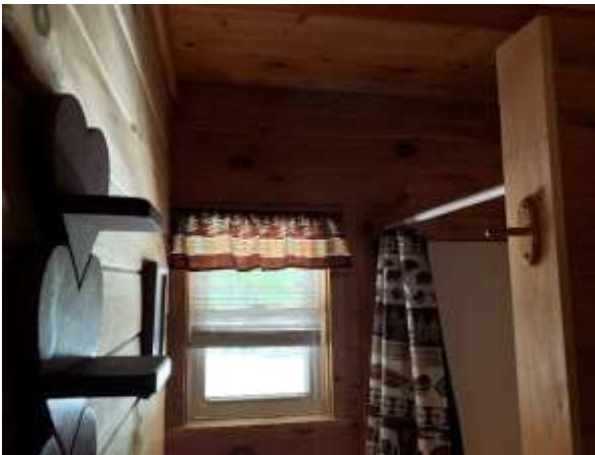
Figure 58 No mechanical Ventilation

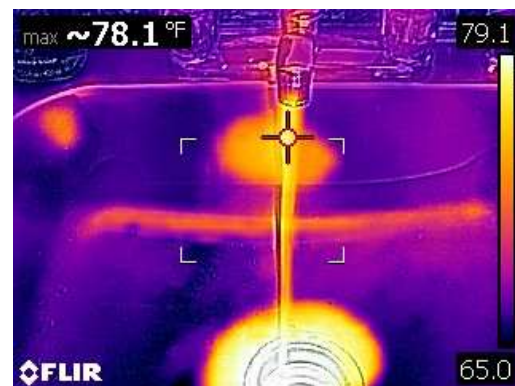
Figure 65 Water Temperature

I observed proper drainage of the sink. I observed a noticeable drop in pressure when more than one faucet was operated simultaneously. The hot water temperature at the sink was 78.1° and the sprayer worked as designed. There was an improper "S" trap at the sink. The sink was not properly fastened to the countertop. **Recommend further evaluation by a licensed plumber regarding the trap configuration.**

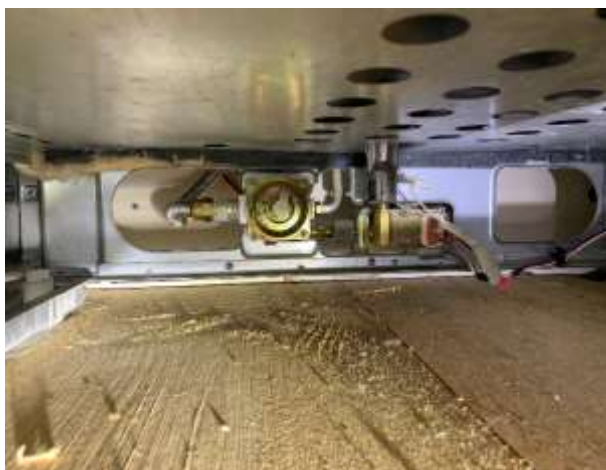
I operated all burners and briefly ran the oven. I observed that there was no visible anti-tip bracket at the stove. Anti-tip brackets are metal devices designed to prevent freestanding ranges from tipping. They are normally attached to a rear leg of the range or screwed into the wall behind the range and are included in all installation kits. A unit that is not equipped with these devices may tip over if enough weight is applied to its open door, such as that from a large Thanksgiving turkey, or even a small child. A falling range can crush, scald, or burn anyone caught beneath. This part can be purchased at most hardware stores or ordered from a manufacturer.

Figure 67 Lack of Anti-Tip Bracket

Recommend installing an Anti-Tip bracket for safety.

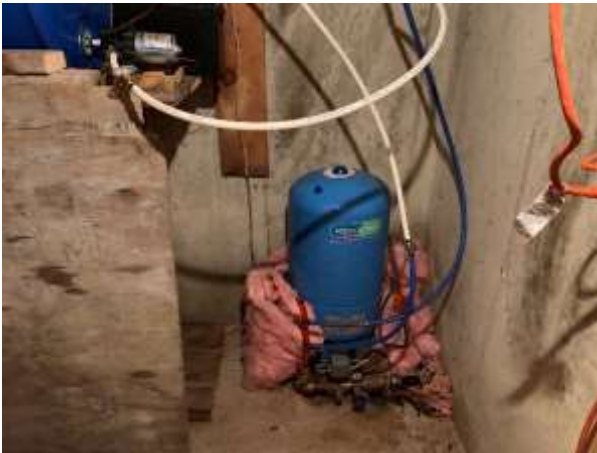
The water supply to this home was a private well. The main water supply shut off was in the northeast corner of the home. The owner had a secondary tank configured to expand the capacity of the water supply when the generator system was shut down. It is unknown if this was done by a licensed professional or was strictly a homeowner install. **Recommend further evaluation by a licensed plumber.**

Figure 87 Pressure Tank

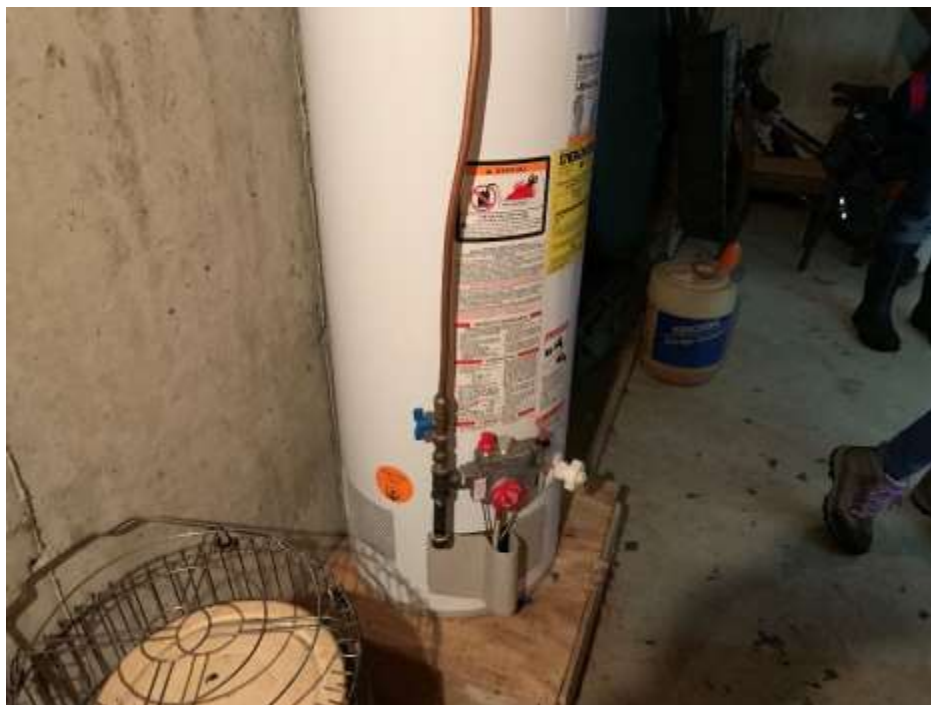
Figure 89 Water heater

The water heater was a GE 30-gallon propane tank. I observed no indications of leakage. I observed an improper TPR valve connection. The TPR valve should have a discharge pipe attached that terminates within six inches from the floor. There was no discharge pipe installed on this unit at the time of inspection. **Recommend further evaluation by a licensed plumber.** The age of the water heater was 13 years. **The typical life expectancy of a water heater is 6 to 12 years. Recommend budgeting for a new water heater at some time.** For more information on this unit, visit <https://products.geappliances.com/appliance/gea-specs/GP30T06AVG00>

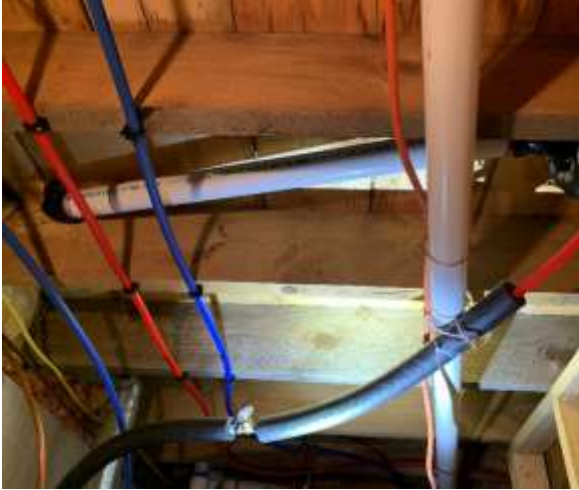
Figure 93 Plumbing Vent

The vent system was plumbed so that the main vent was routed through the wall system and terminated to the soffit vents at the high side of the shed roof. It appeared that all fixtures were connected to the venting system. A plumbing vent should extend outside of the home to avoid any gasses entering the home through a window or other opening. This current configuration is not typical, and I would **recommend further evaluation by a licensed plumber.**

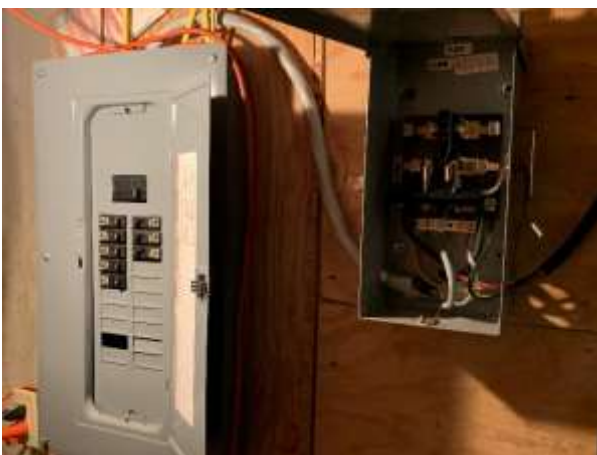
Figure 95 Main panel with generator disconnect switch

The generator was wired directly to a shut off switch and then to the main panel. The entrance cable from the generator was routed through a knockout in the side of the switch panel. There was no means of fastening the wire and left a gap which could allow rodents to enter the panel. There was a missing knockout in the main panel which is a safety hazard. The main entrance to the panel from the generator shutoff was installed in a haphazard way and was not a proper installation. The cover to the panel was installed upside down which makes it difficult to read the circuit breaker labeling. The breakers and wiring looked proper, but I would **recommend further evaluation by a licensed electrician to address the above issues.**

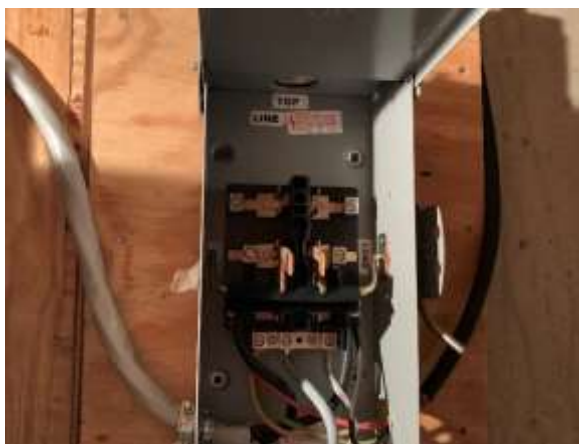
Figure 96 Generator Disconnect
