# Patriot Home Inspections, LLC Comprehensive Home Inspection Report

**Inspection Address: 1122 Harmony Avenue, Sometown, Maine**

**Date of Inspection: 7/8/2021**

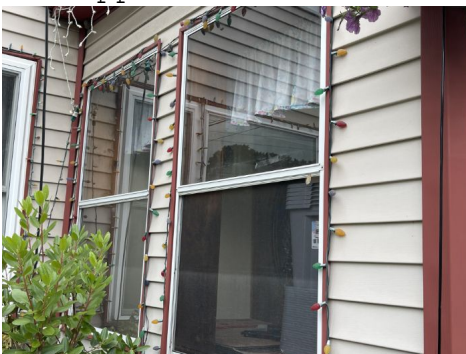
- Some window screens were missing and some were damaged.
- Peeling paint observed, suggest scraping and painting as necessary.
- Minor wood softening noted. Recommend ongoing maintenance.

Several ripped screens

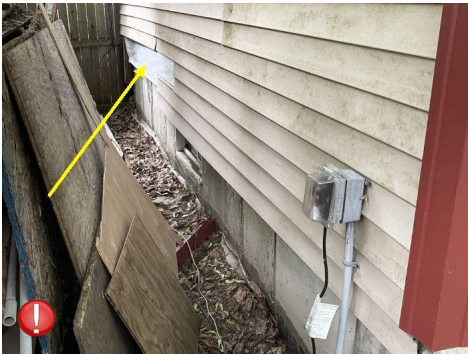
- Minor vinyl siding damage was observed. Typical but should be addressed to avoid moisture intrusion.
- There was an area of unfinished siding at the far side of the addition. Recommend having this sided as soon as possible.
- The dryer vent was uncovered at the time of the inspection. This allows vermin to enter the home via the dryer ductwork. Recommend repairs.
- The siding at the window flower boxes was pulled away from the home due to the weight and method of attachment. Recommend repairs to this area of siding to keep water from getting in behind the siding.

Unfinished siding

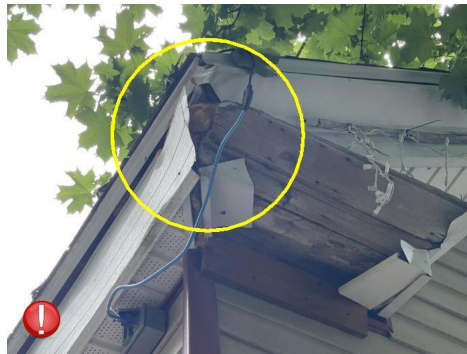
- There were areas of the eaves that had loose soffit coverings. Recommend repairs.

Loose materials at soffit

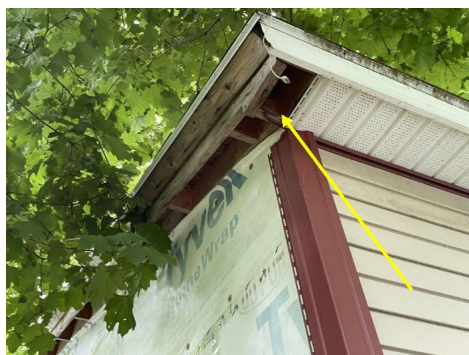
- There were open soffits noted. It was brought to my attention from a neighbor that there had been issues with squirrels at this home. Recommend further evaluation to determine a course of action to keep this from happening. I noted a pidgin roosting at the eaves, it was unknown if there may have been a nest there, but it came back several times.

Possible nesting

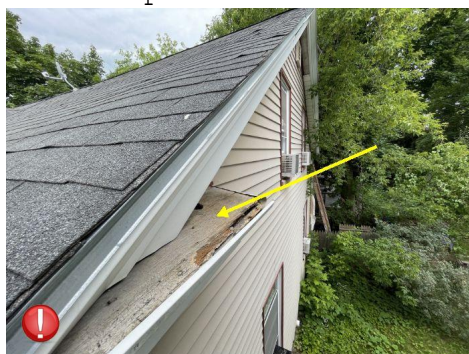
Open soffits

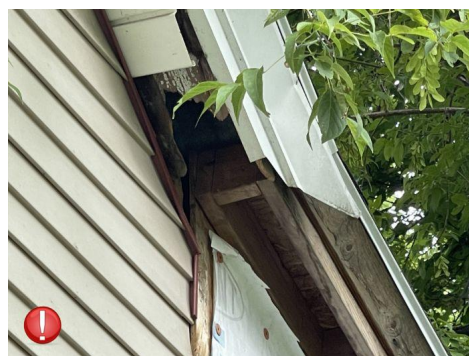
- A section of the fascia at the addition was missing. Recommend repairs.

Soffits missing

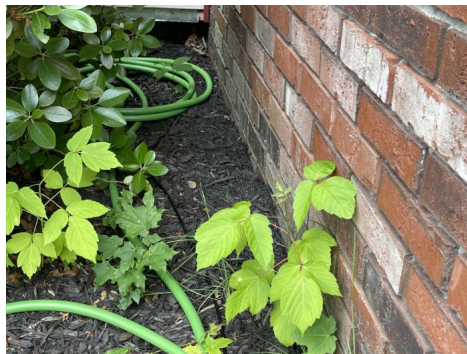
- Lot grading and drainage have a significant impact on the building, simply because of the direct and indirect damage that moisture can have on the foundation. It is very important, therefore, that surface runoff water be adequately diverted away from the home. Lot grading should slope away and fall a minimum of one (1) inch every foot for a distance of six (6) feet around the perimeter of the building.
- There were some low spots along the foundation. Recommend adding additional back fill to create the proper slope away from the house to allow for effective drainage.

Low spots

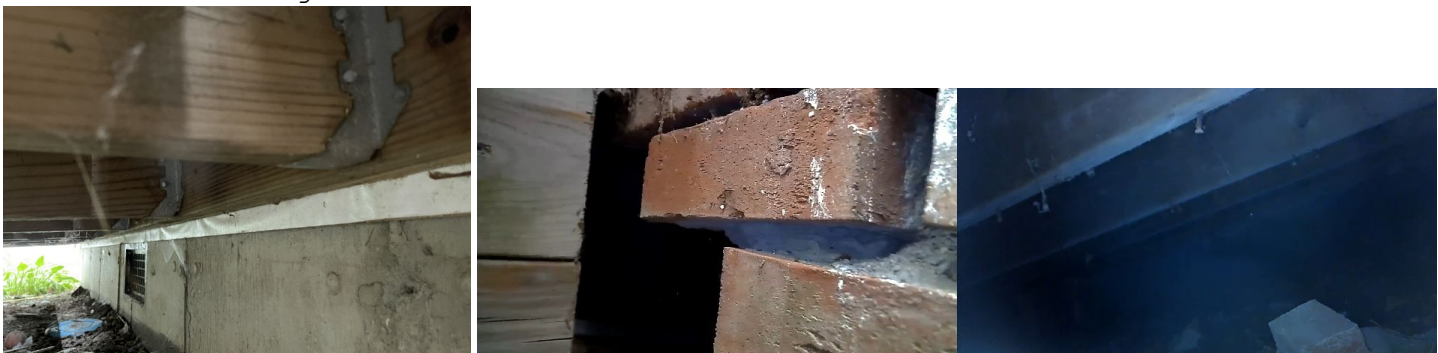
- **Wood to Soil Contact at deck supports. Deterioration may occur and insects may gain access to wood.**

Wood touching soil

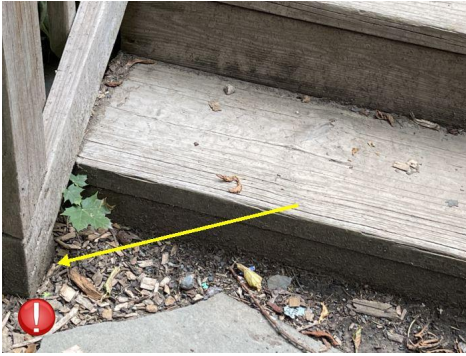
- Wood to Soil Contact at deck supports. Deterioration may occur and insects may gain access to wood.
- Unstable railings were observed.

Wood touching soil

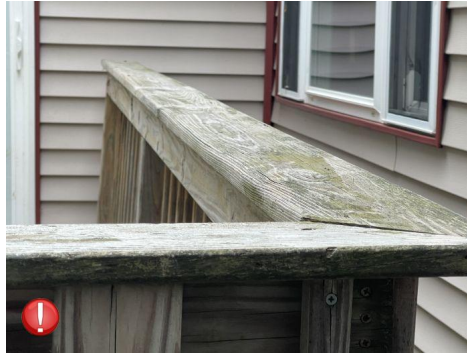
Loose Railing

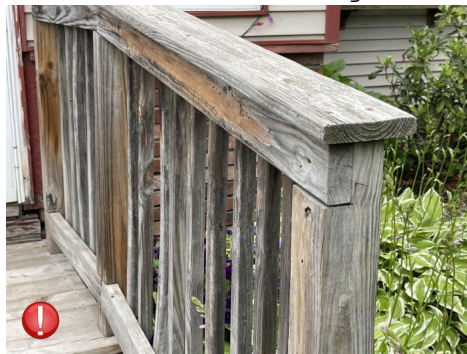
Unstable railing

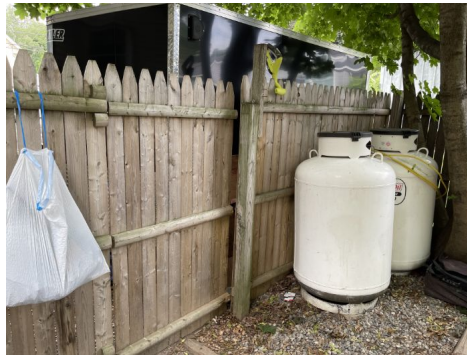
- Fence leaning in areas.
- Wood deterioration observed. Suggest repairs/replacement as needed.

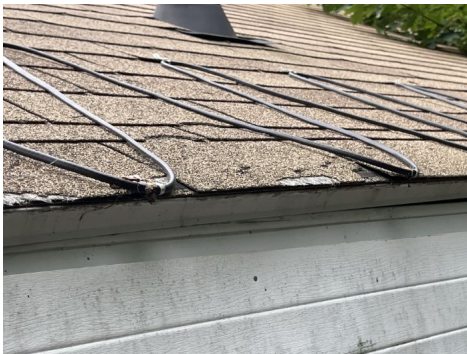
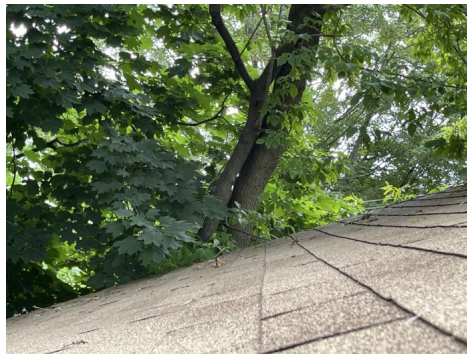
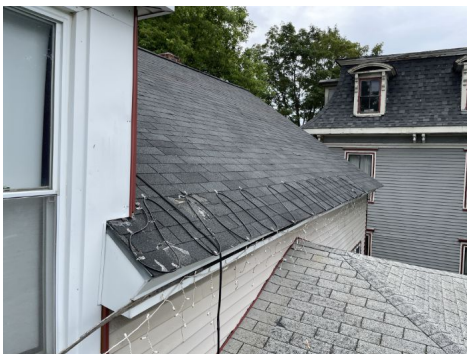
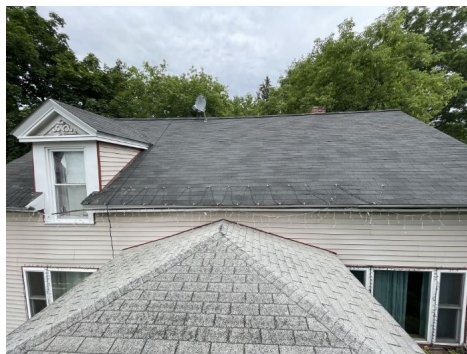
- Some shingles were observed to be damaged. Curling, missing shingles and/or tabs. Recommend repair by a roofing specialist.

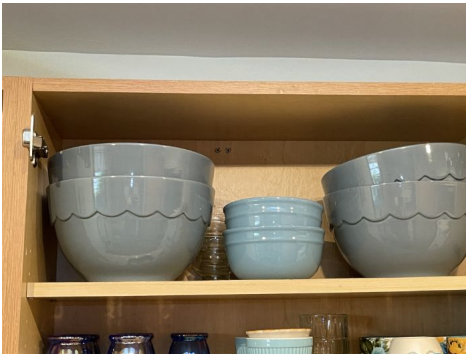
- Cabinets were missing doors at the time of the inspection. It is recommended to ask the homeowner if they are stored on the premises and request that they be installed prior to close.

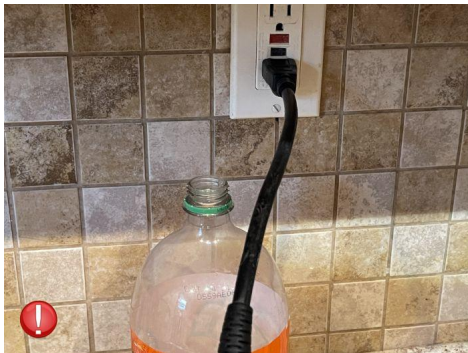
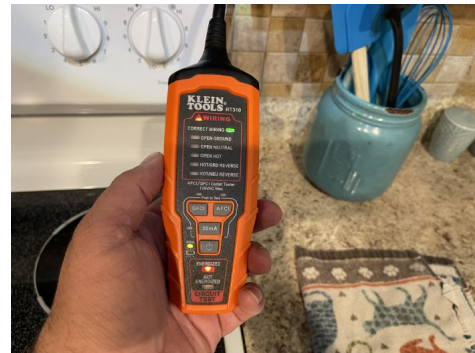
- There was no **GFCI** protection to the left or right of the kitchen sink

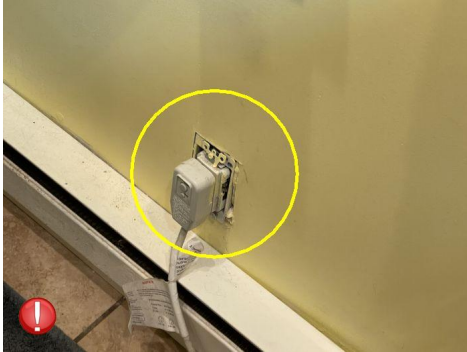
- Outlet needs new cover.

Missing outlet cover

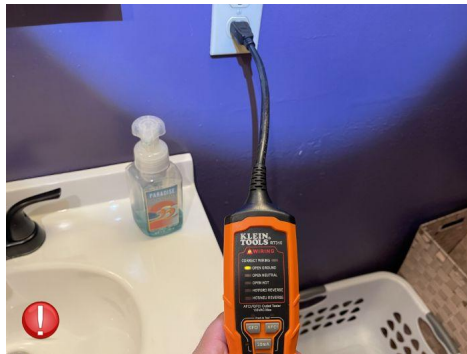
- GFCI did not respond to test, suggest replacing for safety.

GFCI not operational

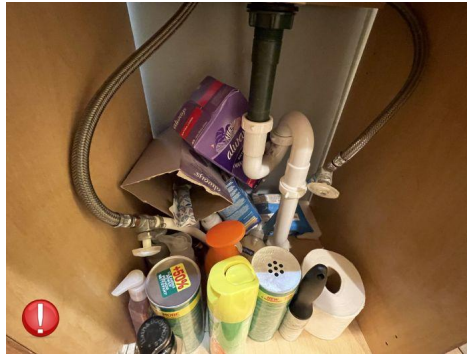
- A common plumbing defect found in many older houses is an "S" trap. An "S" trap is named so because it looks like an "S" on its side - it basically consists of a normal trap, and then another trap installed right up against it in an upside-down fashion. These traps are prohibited by many state's codes.

"S" Traps have the potential to suck, or 'siphon', water out of the trap as the water flows down the drain. On a properly installed "P" trap, there is a vent at the same place the drain turns downwards, which breaks the siphon. The vent prevents water from getting sucked out of the trap.

S Trap

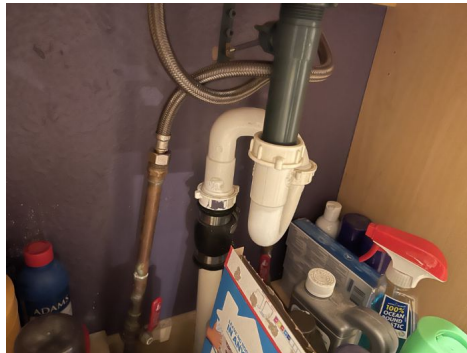
S Trap

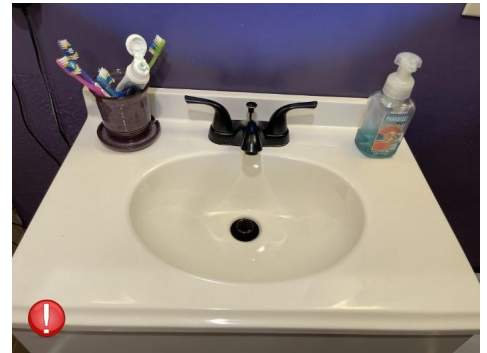
Slow drain at upstairs sink

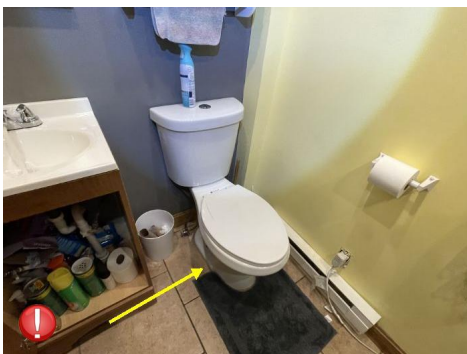
- Caulking needed under the toilet

No caulking under toilet

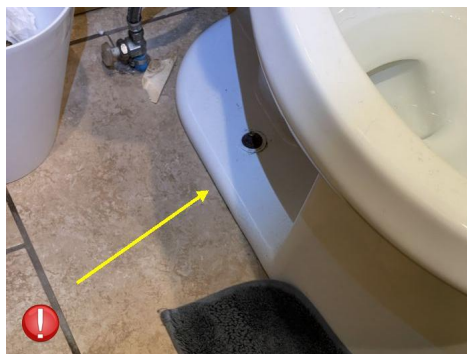
Caulking missing

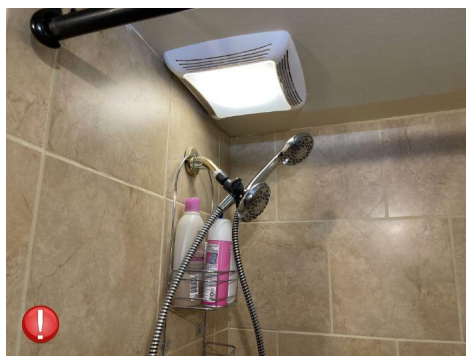
- The bath fan was located in the shower area. This is not an acceptable application.

Showers are poor locations for exhaust fans

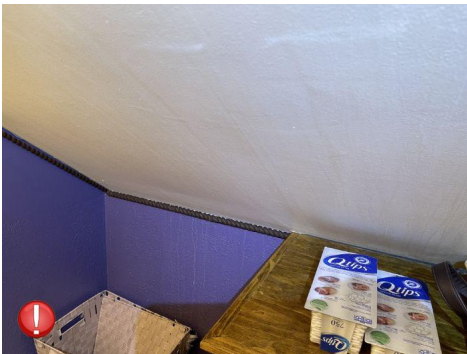
- There were some signs of elevated moisture in the bathroom, most likely caused from showering without the vent fan running or not running the fan long enough. This can cause issues with wallpaper and paint on the ceiling. It is highly recommended to run an exhaust fan with every shower and continue to run it for up to 15 minutes after your shower to remove as much moisture as you can.

Moisture streaking from lack of proper ventilation

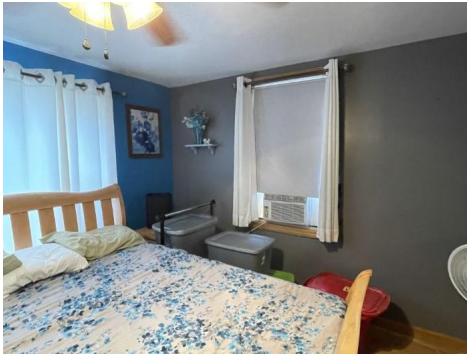
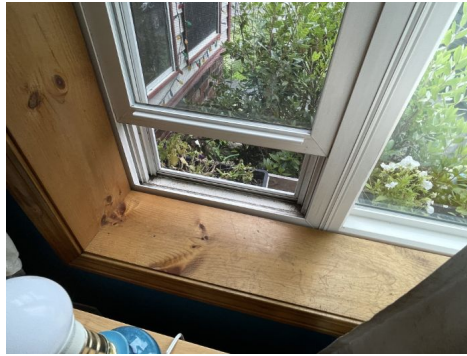
- It is highly recommended that all windows are operated at the final walk-through inspection.
- All accessible windows operated normally
- Most bedroom windows were not accessible at the time of the inspection due to the installation of portable air conditioning units.

Most windows were fitted with AC units and were unable to be thoroughly inspected.

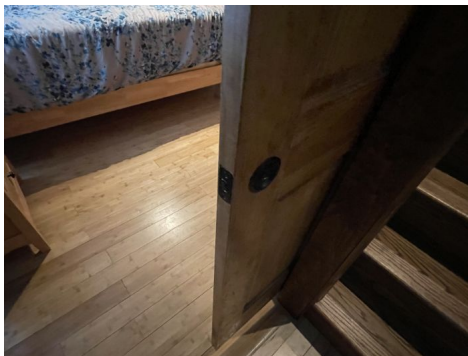
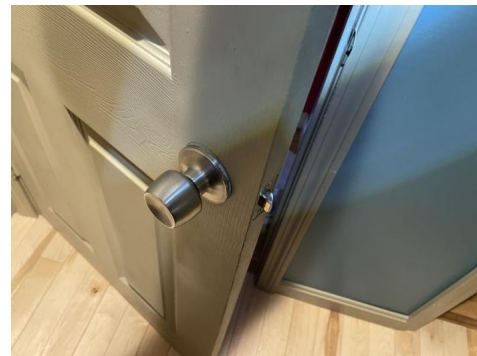
- No privacy locks on most bedroom doors.

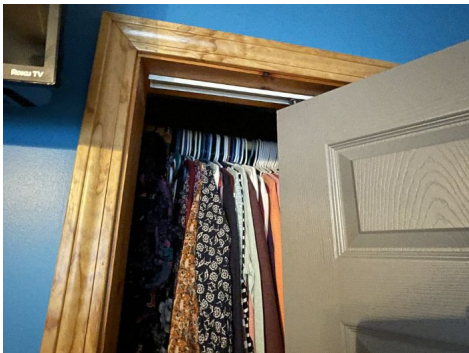
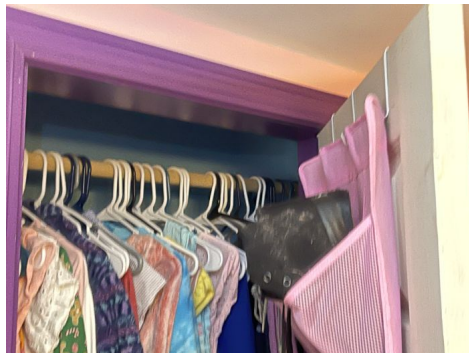
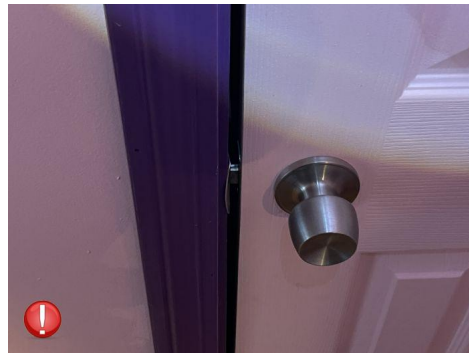
Closet door did not shut properly

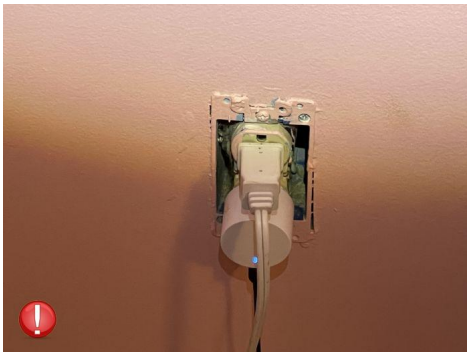
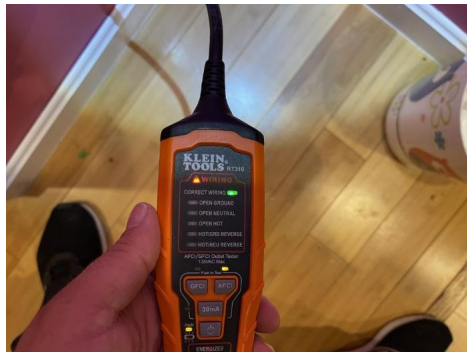
- Some outlets not accessible due to furniture and or stored personal items.
- Missing cover plates observed, suggest installing for safety.

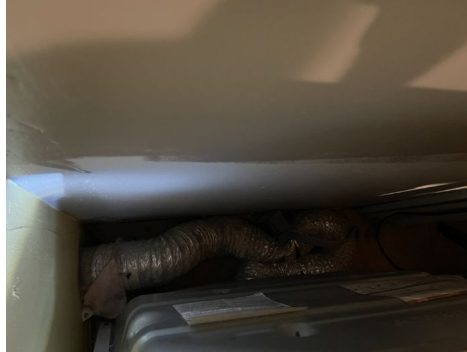
- The dryer vent was missing the exterior cover.

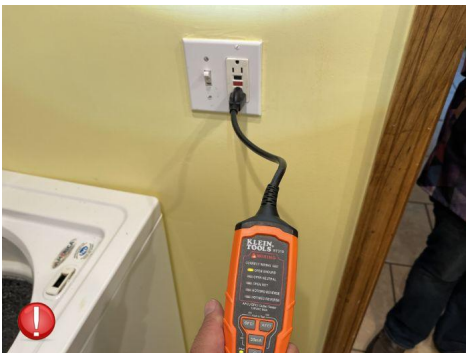
- Some outlets not accessible due to furniture and or stored personal items.
- Outlet cover plates missing.

Cover Missing

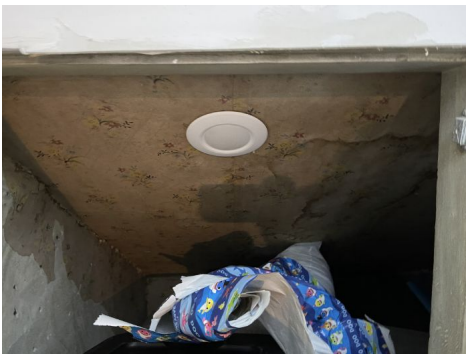
- Small stains noted on the ceiling. They tested dry at the time of the inspection.

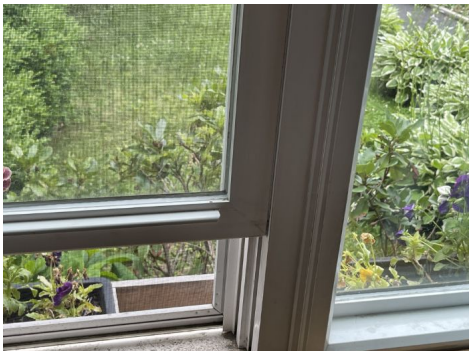
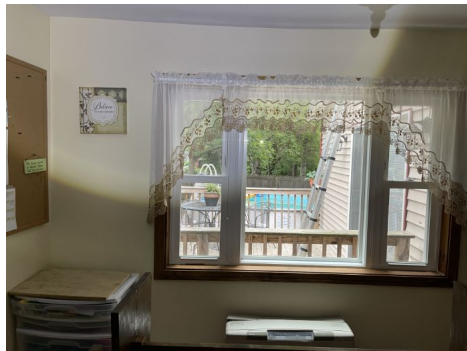
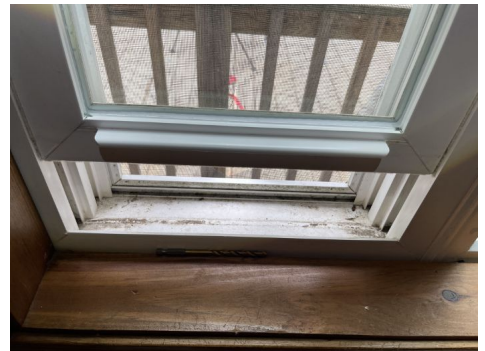
- In accordance with NACHI Standards, I do not test every window in the house, and particularly if it is furnished. I do test every unobstructed window in every bedroom to ensure that at least one provides and emergency exit.
- Operated windows appeared functional, at time of inspection

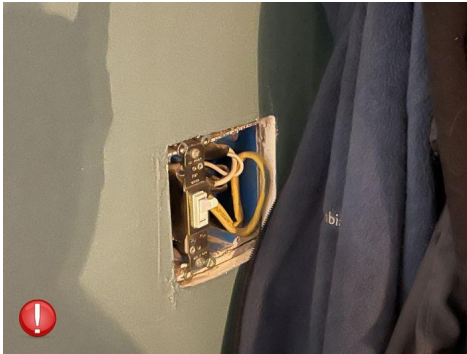
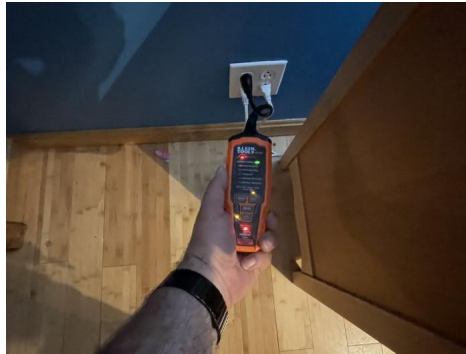
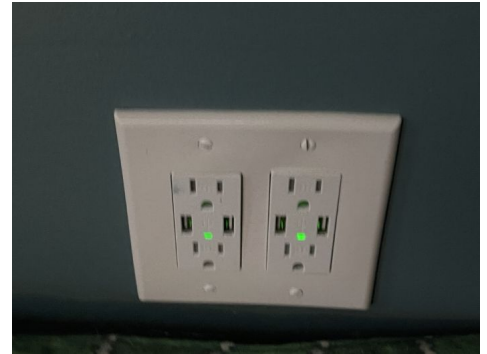
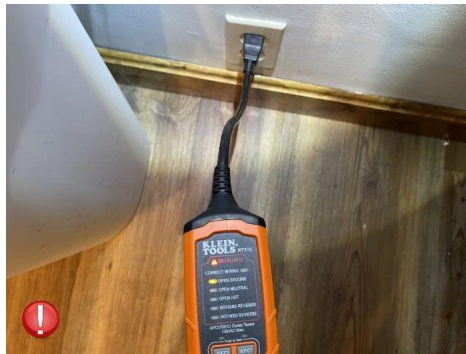
- Ungrounded outlets are a safety hazard and are in violation of the building and national wiring codes. They need be made safe immediately. In older homes, the original wiring did not have ground wire connected to the outlets. These ungrounded outlets are easily distinguished by their two hole/slot configuration versus the newer grounded type of outlet that has three holes/slots. Ungrounded outlets that have two holes/slots used in a home that was originally wired in this manner and has not been rewired are considered acceptable.

- Reversed polarity on an electrical outlet is dangerous. If you accidentally reverse these wires the device you plug in to the receptacle may "work" but it is unsafe and risks a short circuit, shock, or fire.

- Since ungrounded receptacles were noted in the home, buyer is cautioned that proper grounding is strongly urged where sensitive electronic equipment is used. Ungrounded receptacles do not offer protection for computers etc. Consultation with a qualified electrical contractor is recommended.

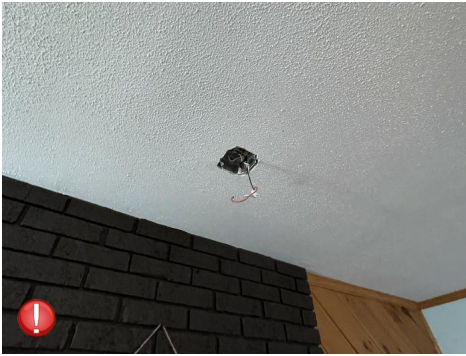
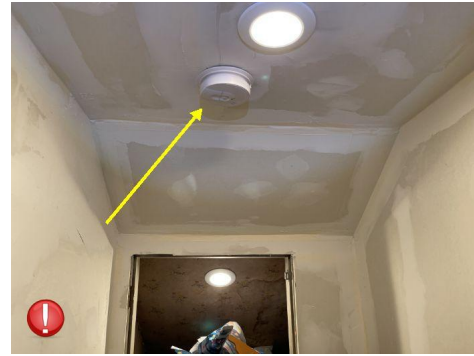
Located inside a closet behind a door

- IMPROVE: Recommend installing one in each bedroom to bring up to modern safety standards
- IMPROVE: There was no visible CO (Carbon Monoxide) detector(s) in the home. The Consumer Product Safety Commission recommends that every residence with fuel-burning (gas) appliances be equipped with a UL Listed CO alarm. CO is colorless and odorless and thus impossible to detect without a proper electronic detector. At a minimum, put an alarm near the sleeping rooms on each level in your home. For the most trouble-free operation, I recommend the plug-in type -- not the battery operated type -- with digital readout that tells you the peak CO concentration whenever you push the peak level button.

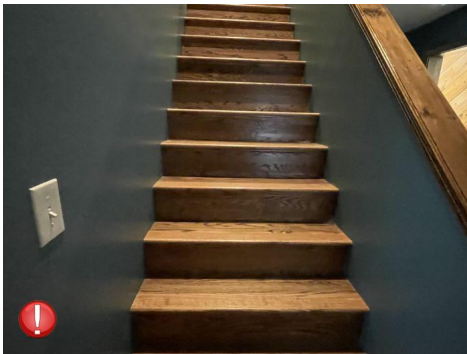
- A handrail was missing.

No graspable handrail present

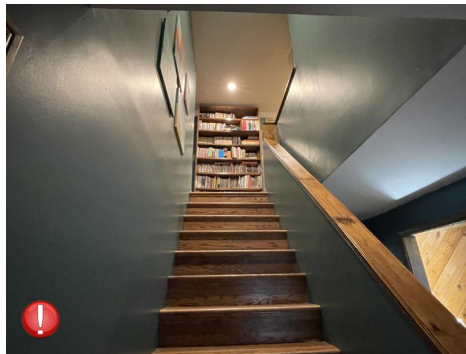
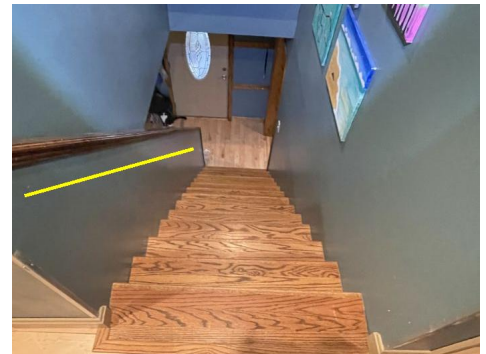
No graspable handrail

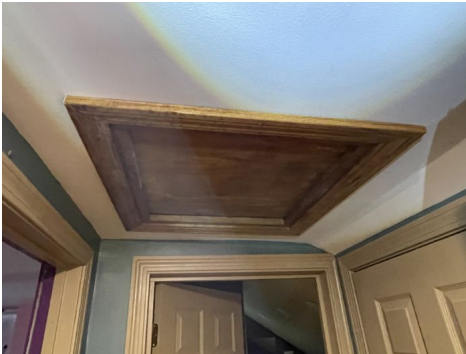
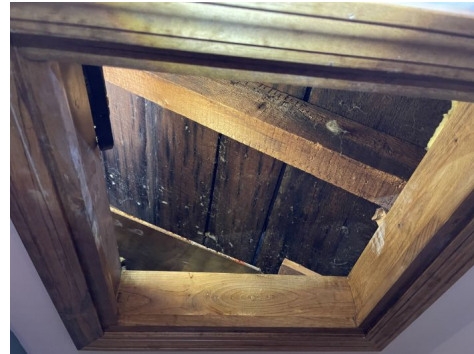
- No major system safety or function concerns were observed at the time of the inspection.
- Scuttle Hole located in upstairs hallway.
- **IMPROVE:** The attic access was not insulated. Expect higher energy costs. Recommend insulating the attic access to reduce energy expenses.
- **Undersized or difficult to reach hatch making inspection limited.**

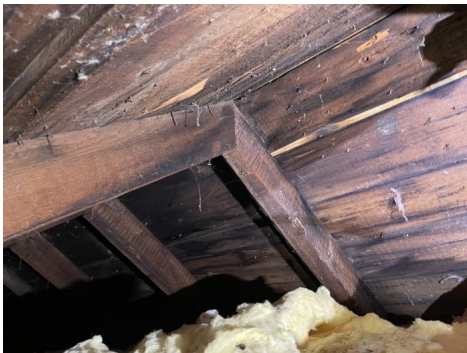
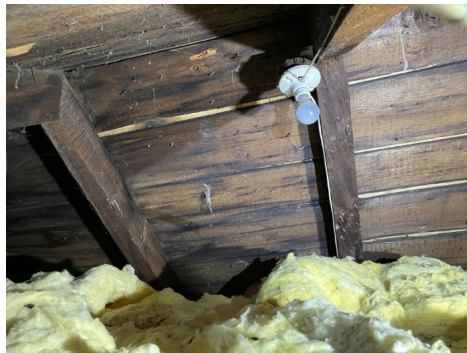
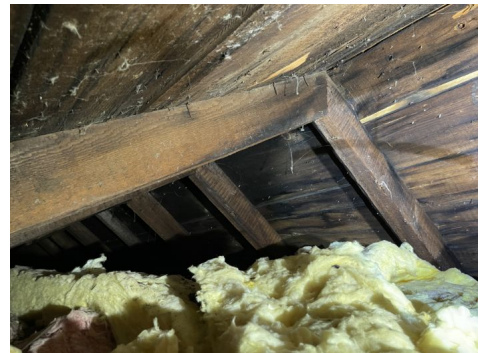
- No major system safety or function concerns were observed at the time of the inspection.
- Could not access fully due to size of entry.

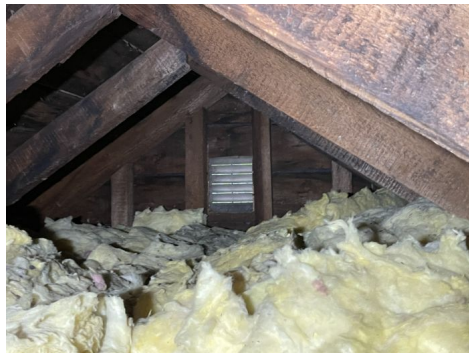
- Gable louver vents noted.

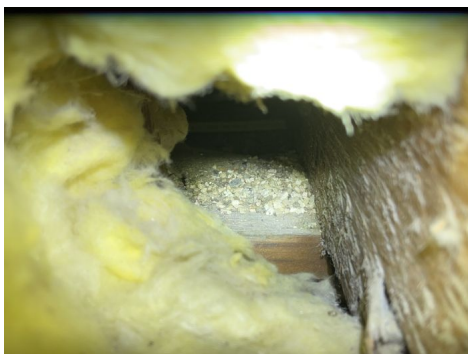
- Apparent vermiculite insulation present; this type of insulation may contain asbestos, which has been linked to cancer (mesothelioma). This inspector is qualified to sample the insulation for you and send it to a national laboratory which will determine if asbestos is present. The EPA makes the following recommendation at <http://www.epa.gov/asbestos/pubs/insulation.html> :

Possible vermiculite insulation under the batting

You should never attempt to remove the insulation yourself. Hire professionals trained and certified to safely remove the material."

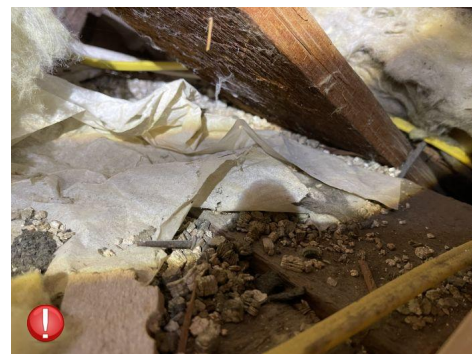
Depth: Insulation averaged about 8-10 inches in depth : more recommended.

Insulation was sparse in areas

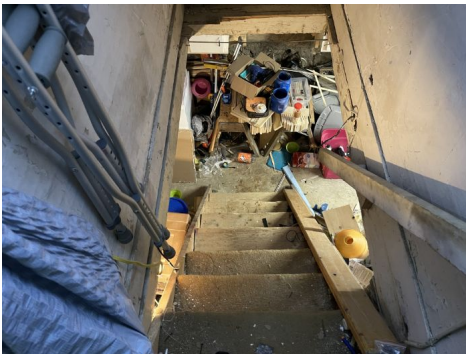
Basement door did not latch

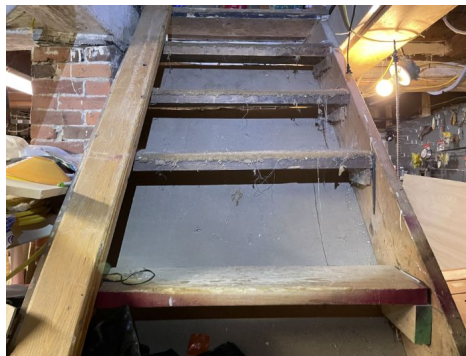
- In the inspectors opinion the stairs are near the end of their useful life.

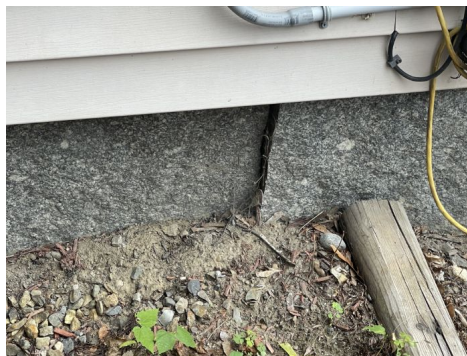
- Efflorescence is a crystalline deposit of salts that can form when water is present in or on brick, concrete, stone, stucco or other building surfaces. It has a white or greyish tint and consists of salt deposits left behind when water evaporates. In addition, efflorescence can appear as a powdery substance on floors and walls and requires special care to treat.
- Moisture intrusion was observed in numerous areas of the foundation. Moisture can create high humidity, mold & can damage stored items & finishing materials. Recommend a wet basement specialist review the foundation for correcting the water intrusion and advise as needed.
- Efflorescence observed; this is a mineral deposit left behind from previous exterior water infiltration.
- Limited review due to storage of personal property and finished walls.

Efflorescence noted

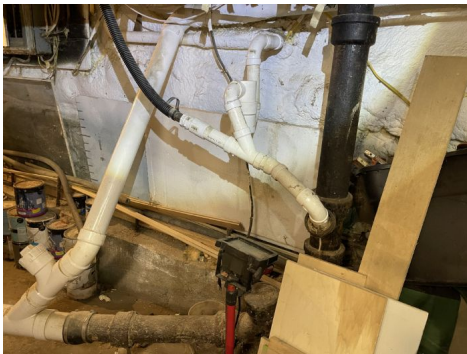
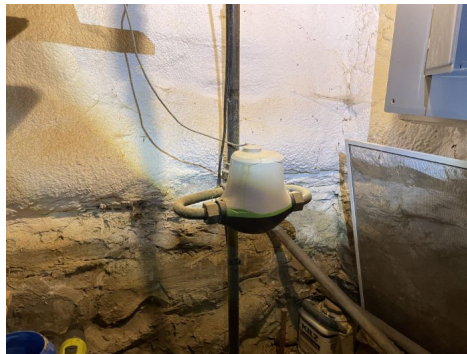
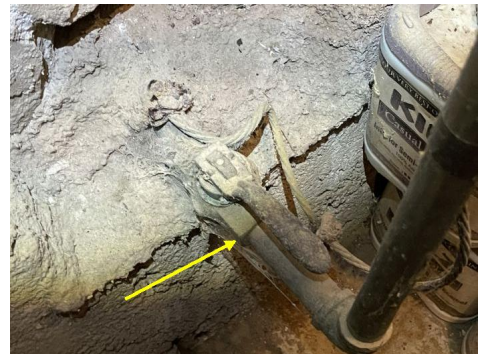
Main water shutoff

- Cast iron drain lines have a life expectancy of 30-50 years. Recommend budgeting for replacement in the near future at areas where rust cysts are visible, BEFORE leaks occur.
  - A full sewer scope was conducted at the time of the home inspection. The findings of the sewer scope will be included at the end of this report.
  - The main water supply shut-off was located at the meter on the back wall of the basement.
- S-trap observed at one or more locations. This type of drain is no longer allowed in current building practice due to the potential for water to be siphoned out of trap, allowing sewer gas to enter structure. If sewer gas is detected first try slowly running water down drain to refill trap assembly. If problem continues consult with a qualified plumber for review and repair.

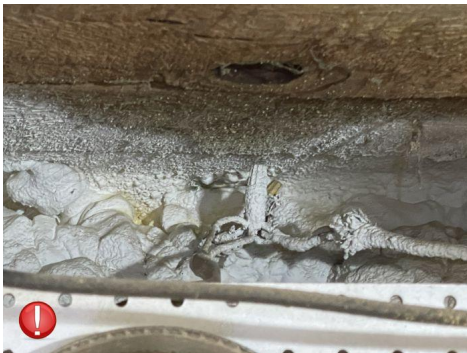
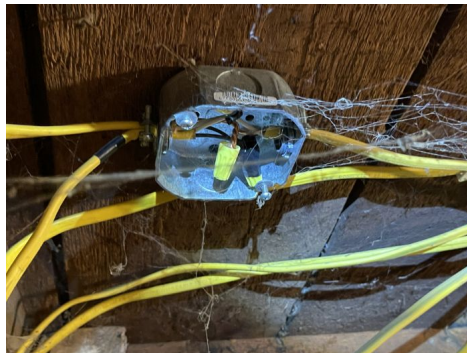
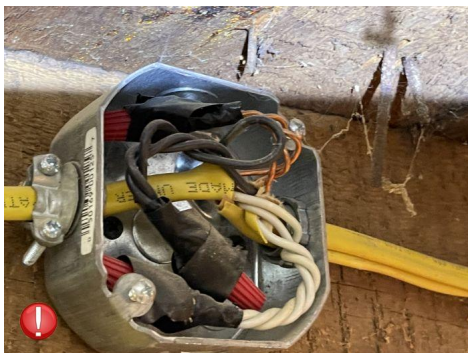
- Open electrical boxes. All electrical boxes should be covered for safety.
- Since ungrounded receptacles were noted in the home, buyer is cautioned that proper grounding is strongly urged where sensitive electronic equipment is used. Ungrounded receptacles do not offer protection for computers etc. Consultation with a qualified electrical contractor is recommended.

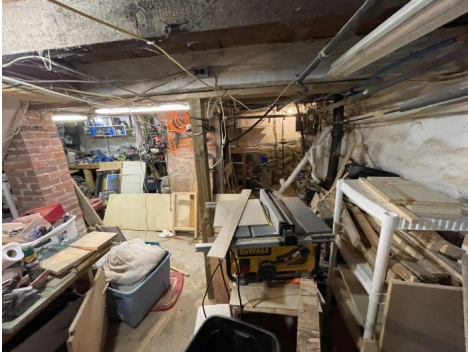
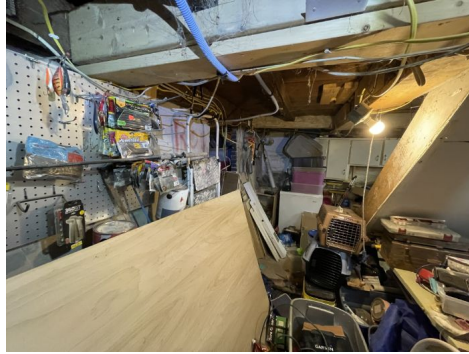
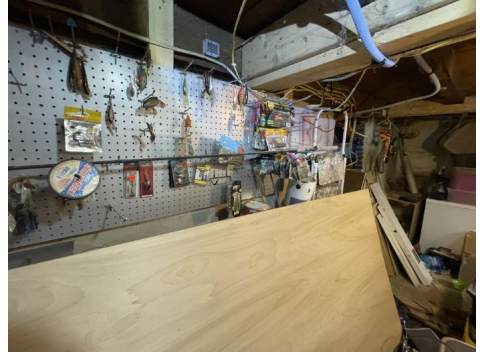
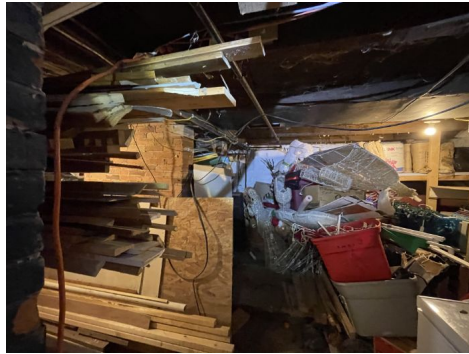
- Common cracks noted. Recommend consultation with qualified contractor should condition worsen or water intrusion occur.

- Inspection was severely limited due to personal belongings stored in the basement. It is highly recommended to have this area looked at once more as the belongings are being removed.

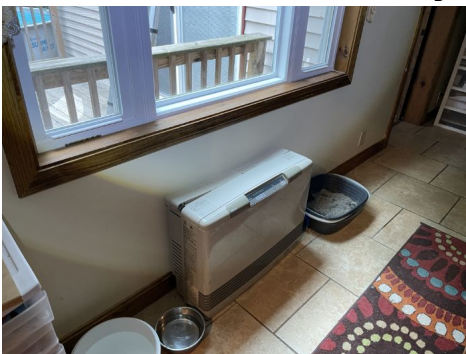
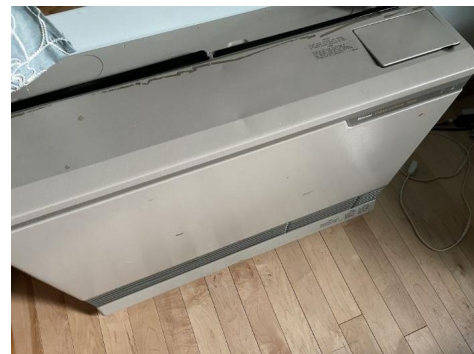
Location: There was no main source of heat in the home.

- This home had two separate propane "monitor" type heaters and electric heat units in several rooms. These heating systems were not operated at the time of the inspection due to the ambient temperature in the home. I did operate a heat unit in the downstairs bathroom briefly and it appeared to function as designed.

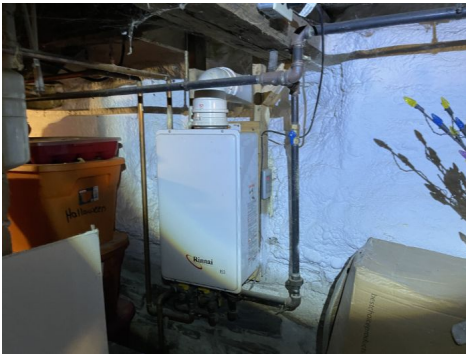
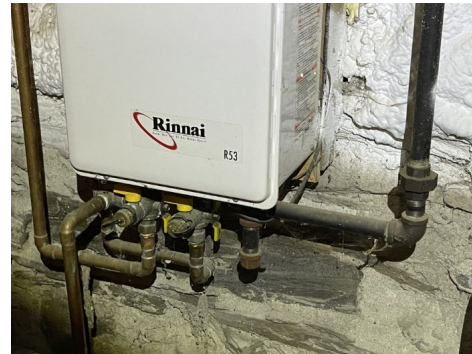
- Water temperature observed to be: 120 degrees F. This is satisfactory. Recommended temp should be set at 118-122 degrees F to prevent scalding, extend water heater life, and improve energy efficiency and conservation.

- Limited access to water heater; not all areas visible for inspection (insulation wrap, etc.).

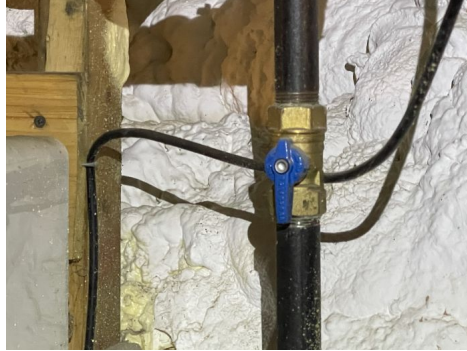
- Could not access the gas valve.

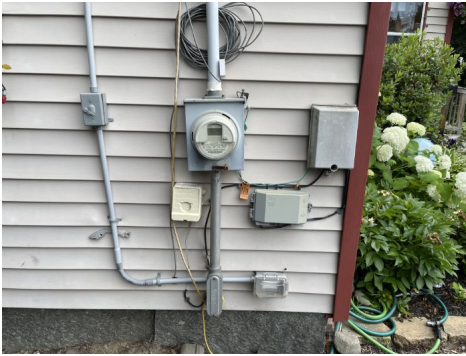
- There was an inadequate drip loop at the service entrance. Recommend repair by the electric company.

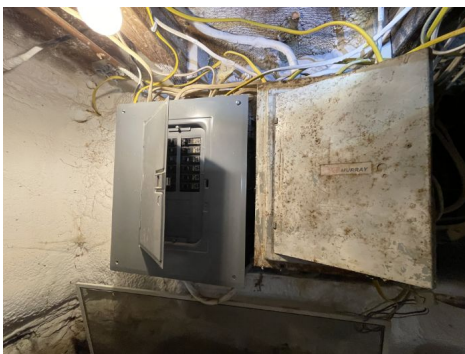
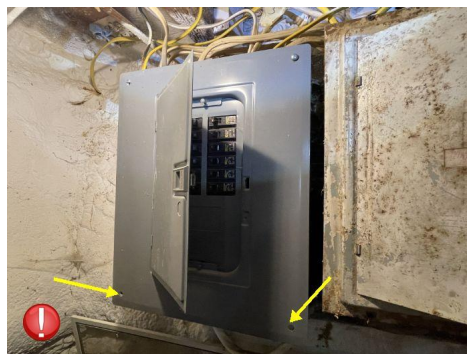
- Access to panel box blocked; interior not evaluated due to safety issues.
- According to the 2008 National Electrical Code, most residential electrical panels require at least a 3-foot clearance or working space in front, 30 inches of width, and a minimum headroom clearance of 6 feet, or the height of the equipment, whichever is greater.
- Panel cover screw(s) missing.
- Sharp-pointed metal screws hold panel cover in place. These are a potential hazard as they may puncture wire insulation and electrify panel box, becoming a shock or electrocution hazard. These screws should be replaced with approved, flat-tipped screws.
- Panel box appears to be older than the projected effective life (25 years) of panel buss bar and breakers; recommend electrician evaluation of panel box and associated wiring, including non-tripping GFCIs on property.

Missing screws

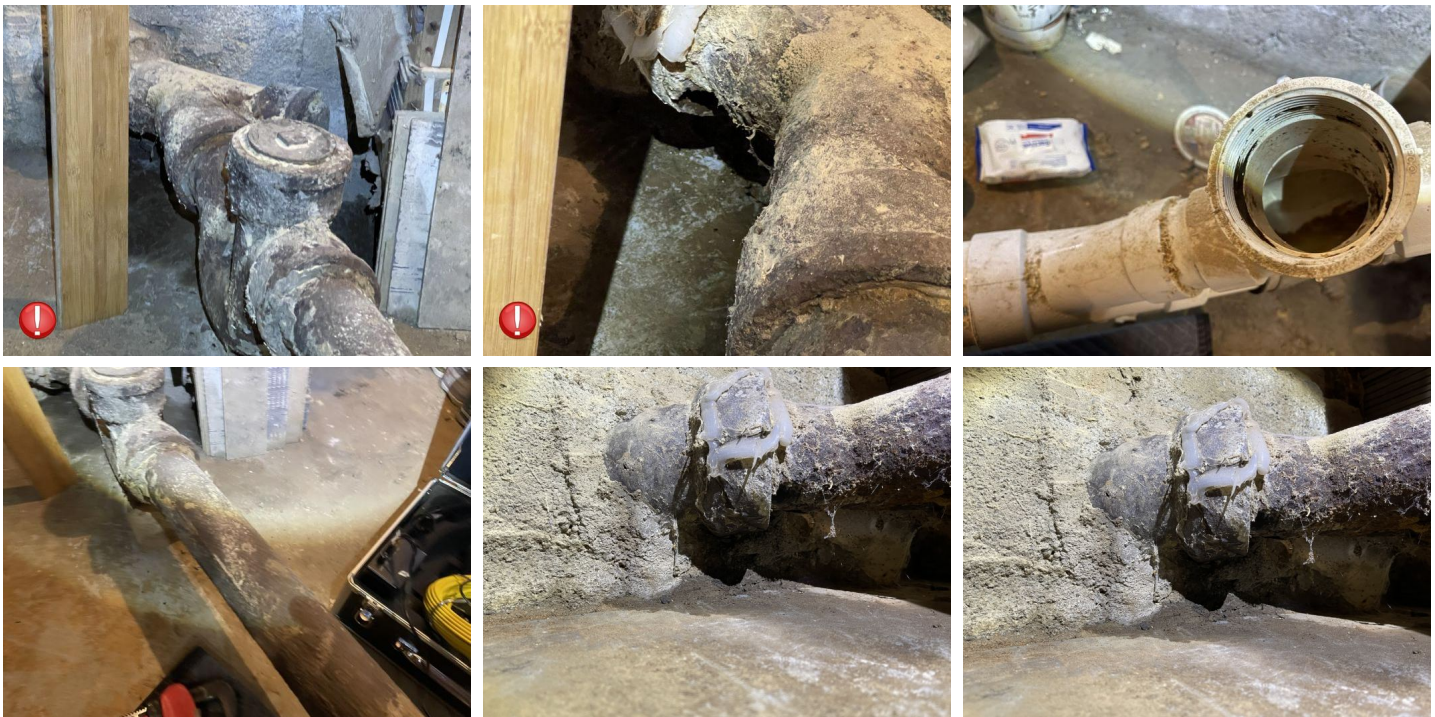
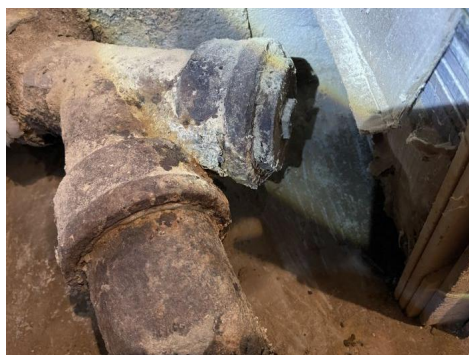
- This home had a leaking cast iron waste system. I was unable to run the camera from the house out to the main due to the configuration of the drain and the condition of the cast iron. Once repairs have been made, I will gladly return to scope the system and determine the condition of the remainder of the line. The home itself had no immediate signs of drainage issues at the time of the inspection.
